- 77 and 78 East Center Street, Woodbury City, Gloucester County
- 856 Main Street, Mantua Township, Gloucester County
- Tyler's Mill Road Bridge over Chestnut Branch, Mantua Township, Gloucester County
- 628-634 Kaighns Avenue (Victory Garage), Camden City, Camden County

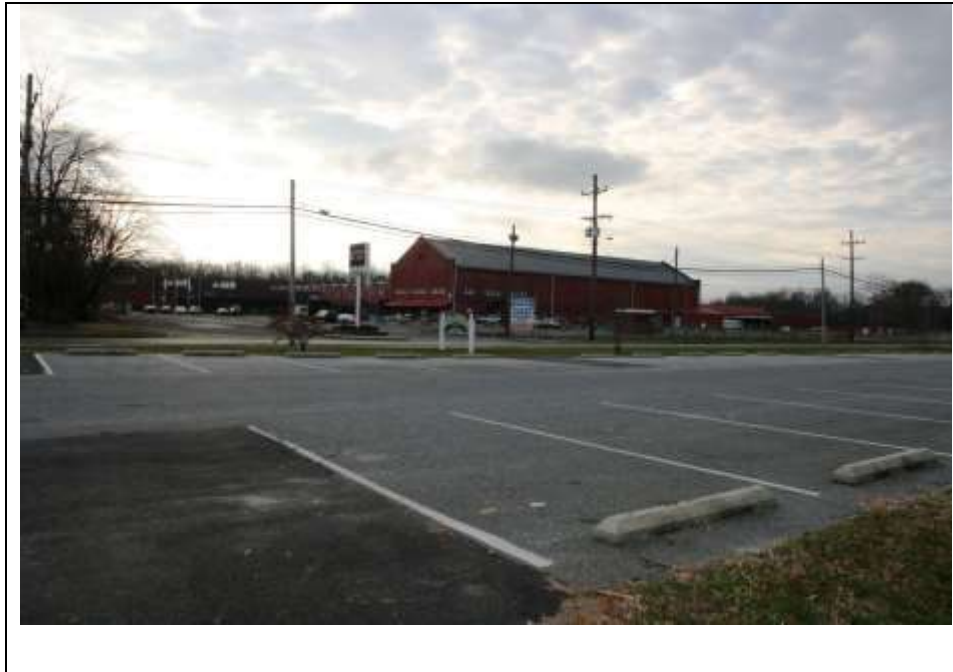
Photograph 1: Overview of the plant from the primary Sewell Street entrance. Looking southwest (December 2018).

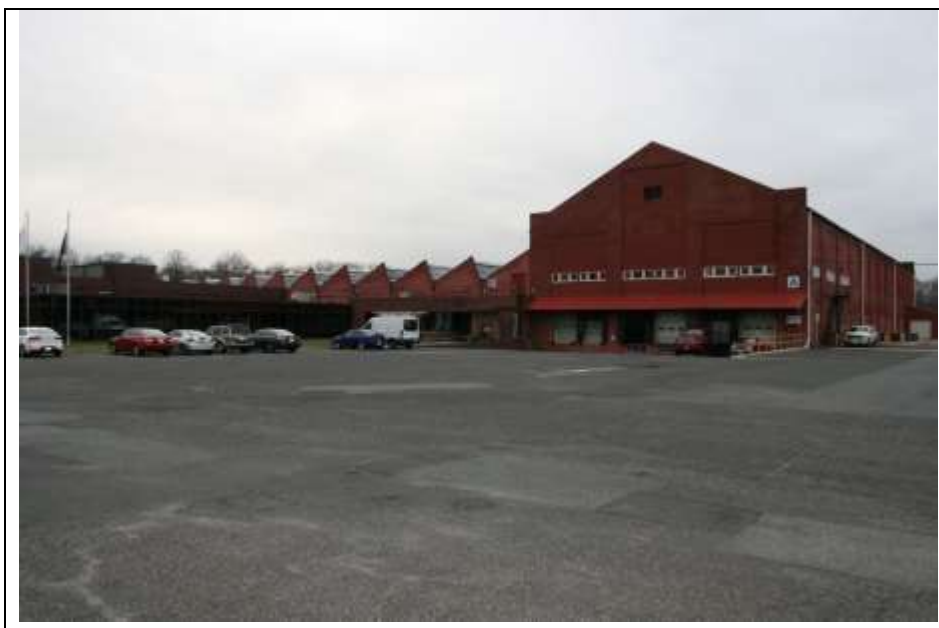
Photograph 3: Southeast elevation (façade) of the 1918 furnace room (Unit A, at right), as well as the attached 1918 manufacturing plant and storehouse (Units D and G, at left background with sawtooth roof) and *circa*-1967 office (Unit C, at left mid-ground). Looking southwest (November 2018).

The entire building rests on a concrete foundation. The manufacturing plant (Unit D), storehouse (Unit G), wooden box shop (Unit H), and machine shop (Unit E) have sawtooth roofs. The steeper, northeast sides of the ridges are glazed to admit natural light into the manufacturing space while shielding workers from direct sunlight. Based on historic Sanborn fire insurance maps, the manufacturing plant (Unit D), storehouse (Unit G), and machine shop (Unit E) had wood block flooring over reinforced concrete slabs; however, it is unclear if the wood blocks remain in place because interior access to the plant was denied (Sanborn Map Company 1923). The furnace room (Unit A), supply storage area (occupying the west side of the storehouse/Unit G), and wooden box shop (Unit H) had concrete floors. The ceiling throughout most of the building consisted of gypsum on exposed steel trusses

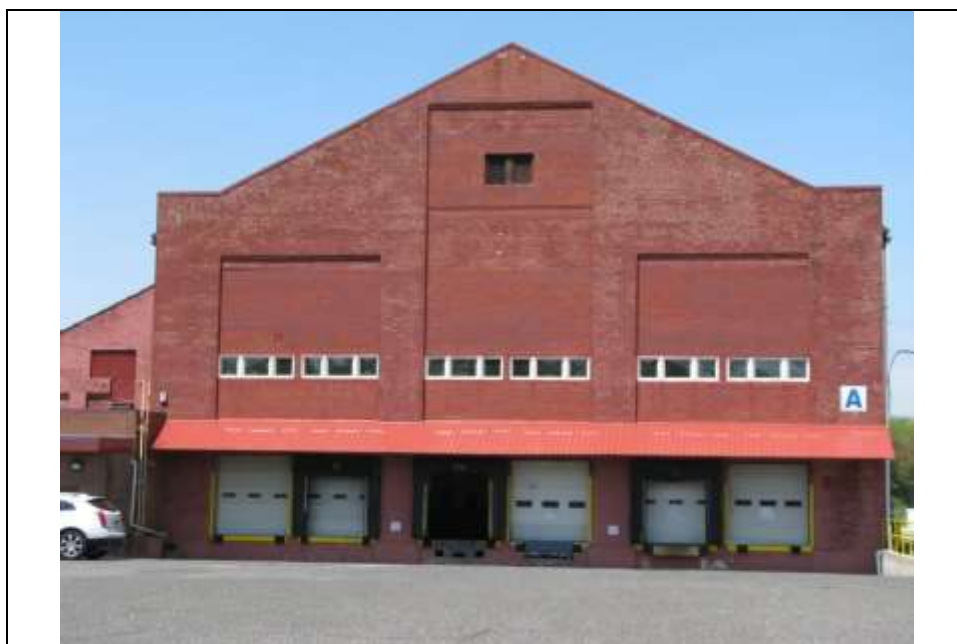
Photograph 4: Southeast elevation (façade) of the 1918 furnace room (Unit A). Looking northwest (May 2014).

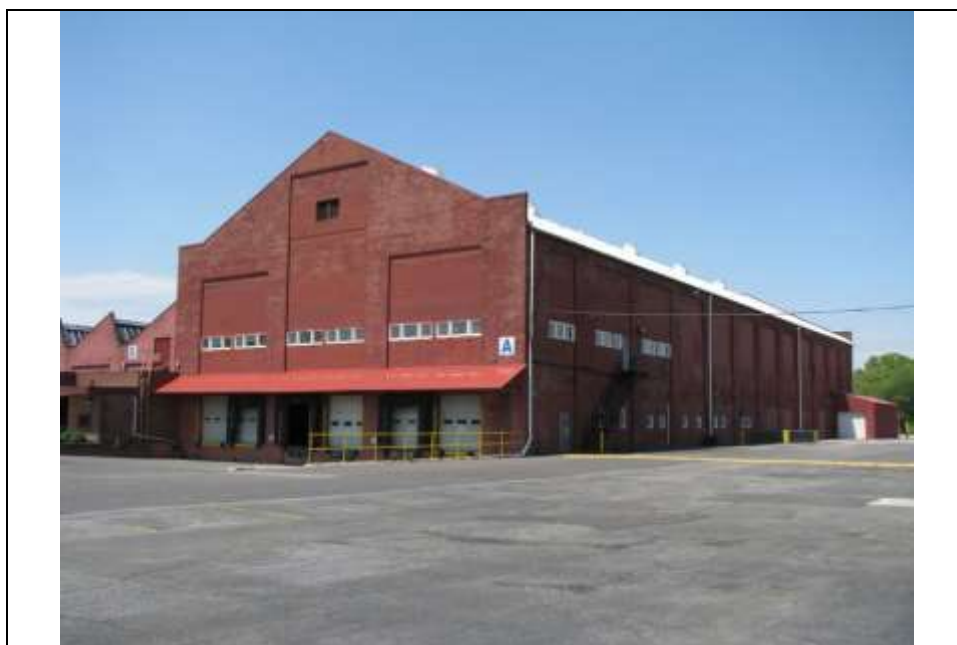
Photograph 5: Southeast (front) and northeast (side) elevations of the 1918 furnace room (Unit A). Note the metal vents that were removed ca. 2017. Looking west (May 2014).

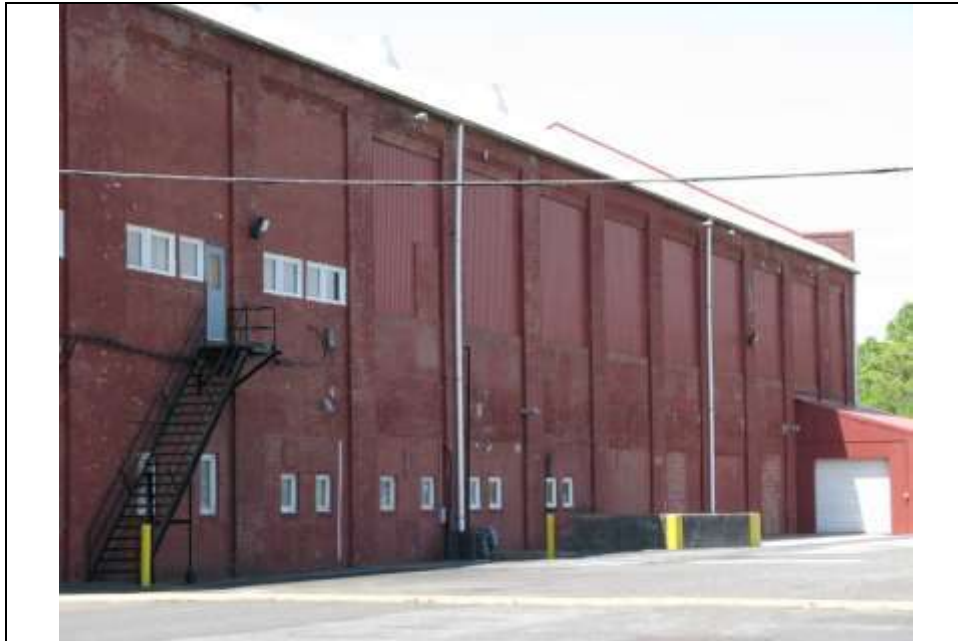
Photograph 6: Detail of northeast (side) elevation of the 1918 furnace room (Unit A). Note the infilled window bays, which originally contained large, multi-light industrial windows, and the modern windows and doors. Looking west (May 2014).

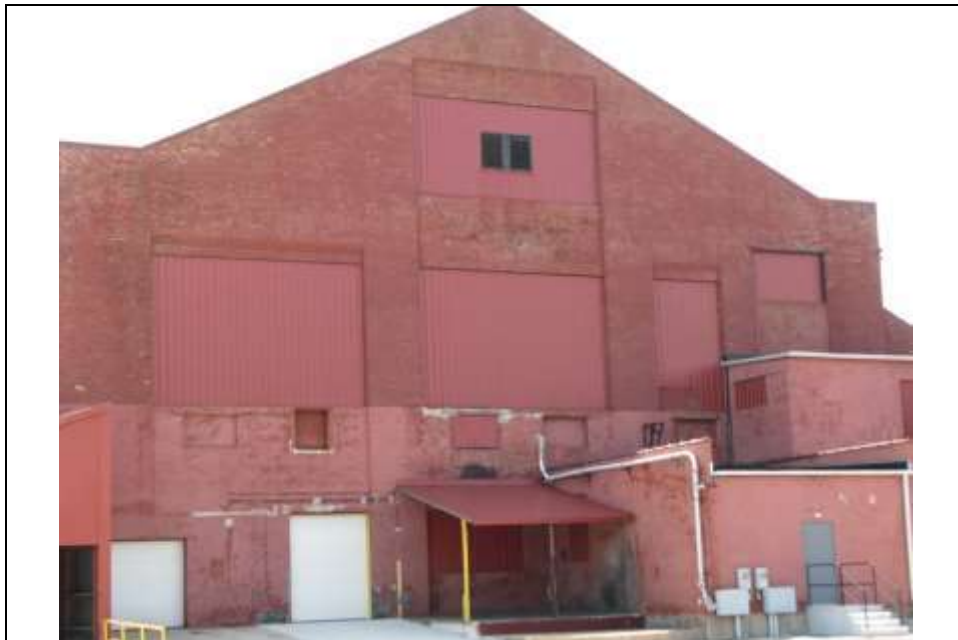
Photograph 7: Detail of northwest (rear) elevation of the 1918 furnace room (Unit A). Note the infilled window bays, which originally contained large, multi-light industrial windows. Looking south (May 2014).

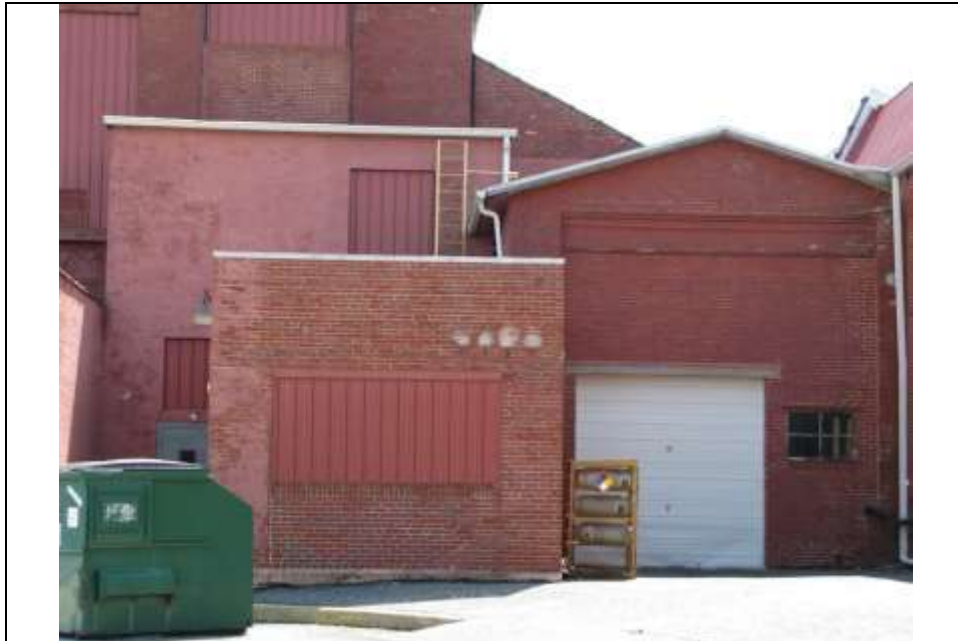
Photograph 8: Detail of small additions attached to the northwest elevation of the 1918 furnace room (Unit A). Looking southeast (May 2014).

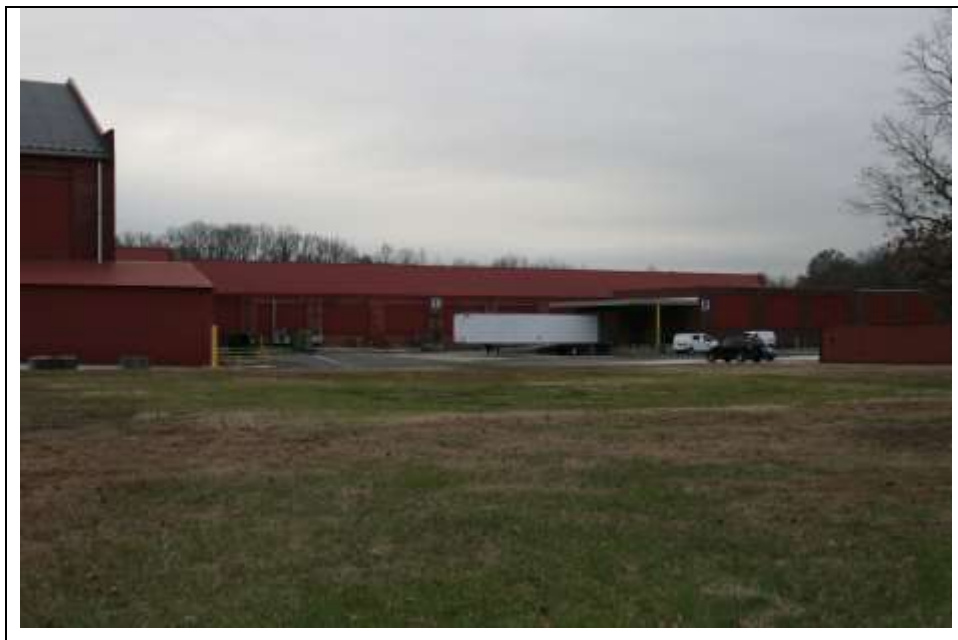
Photograph 9: Northeast elevation of the 1918 machine shop (Unit E). The furnace room (Unit A) is visible to the left; Unit B is to the right. Looking southwest (November 2018).

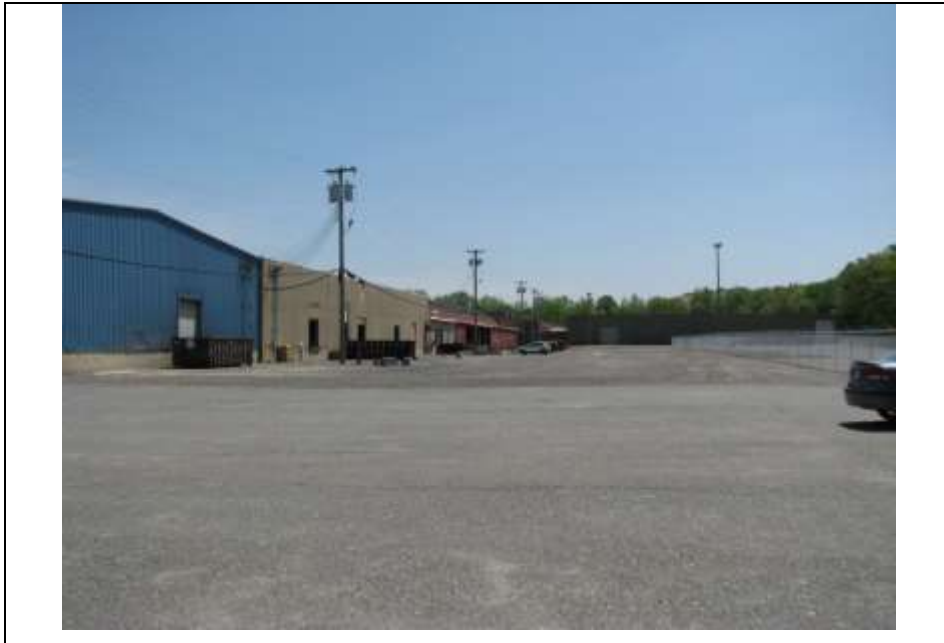
Photograph 10: Overview of the southwest elevation of the plant, showing (at left, from foreground to background) Unit J, Unit I, the wooden box shop (Unit H), and the storehouse (Unit G). Unit K is at right background. Looking southeast (May 2014).

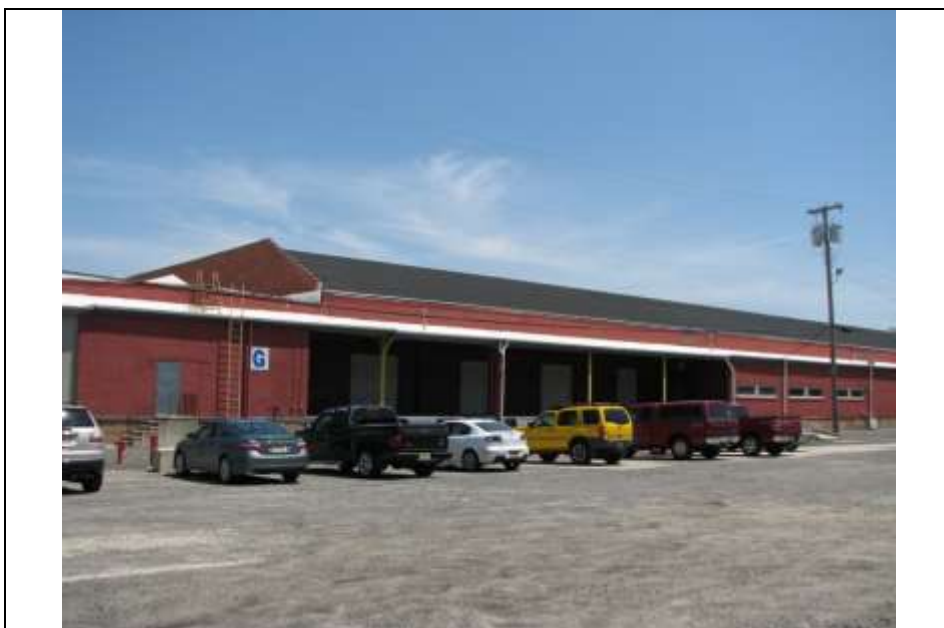
Photograph 11: Southwest elevation of the 1918 storehouse (Unit G). Note the modern doors and windows. Looking east (May 2014).

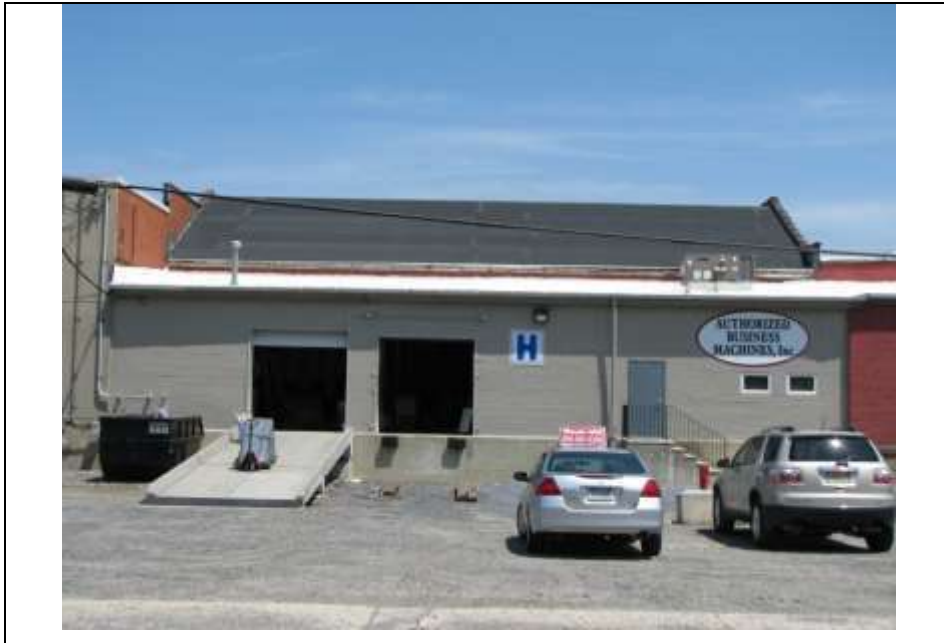
Photograph 12: Southwest elevation of the 1918 wooden box shop (Unit H). Note the modern doors and windows. Looking northeast (May 2014).

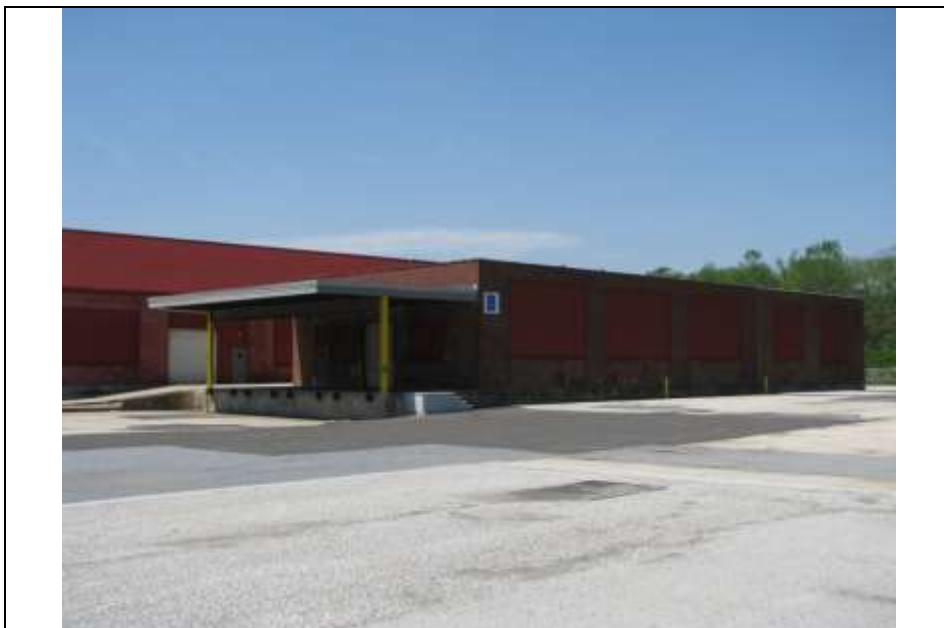
Photograph 13: Southeast and northeast elevations of the 1948 Unit B. Note the modern doors and windows. Looking west (May 2014).

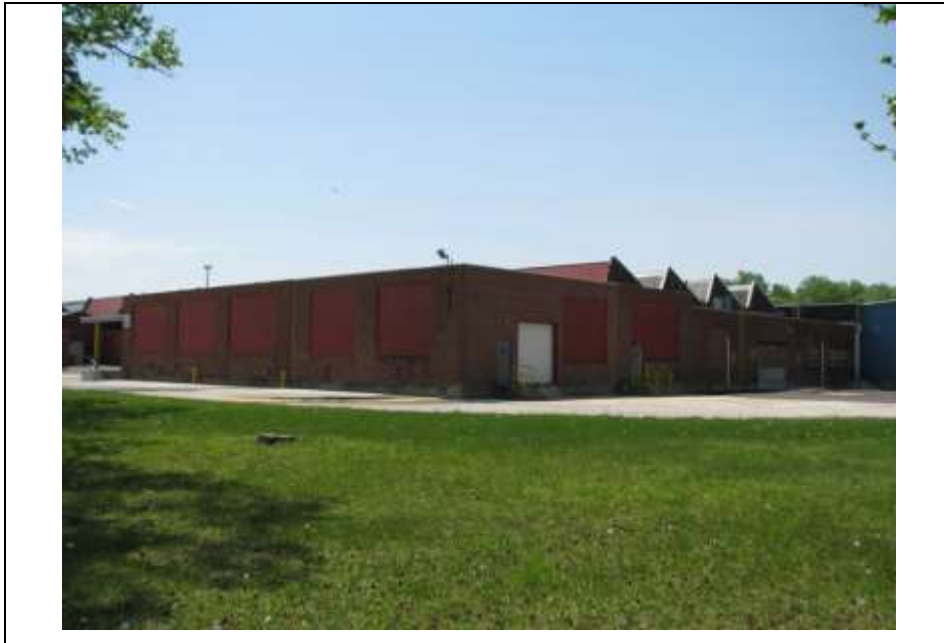
Photograph 14: Northeast and northwest elevations of the 1948 Unit B. The facility with the sawtooth roof (background) is the 1918 machine shop (Unit E). The northwest elevation of Unit E is also visible. Looking south (May 2014).

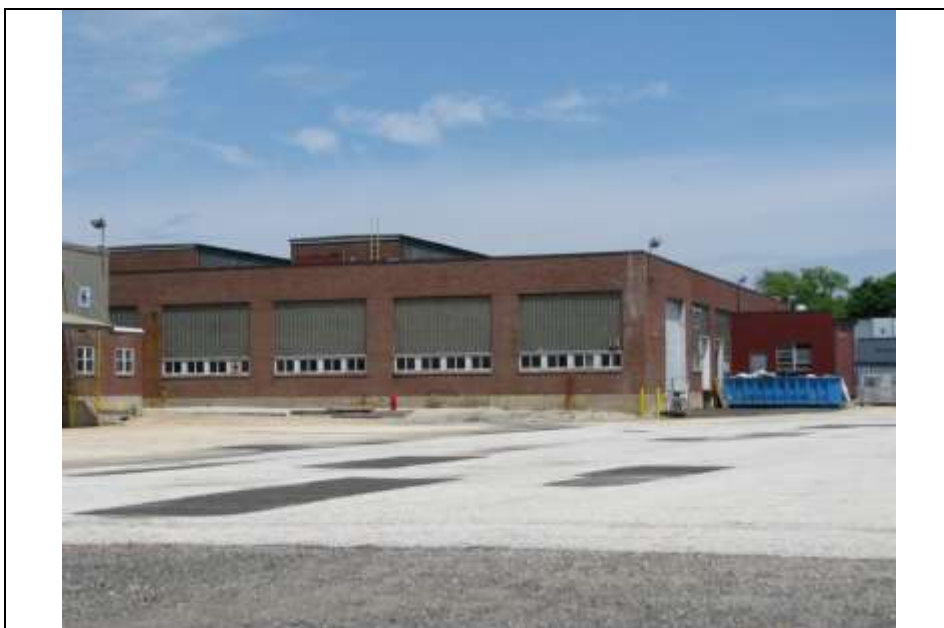
Photograph 15: Southwest and southeast elevations of the 1948 Unit F. Looking north (May 2014).

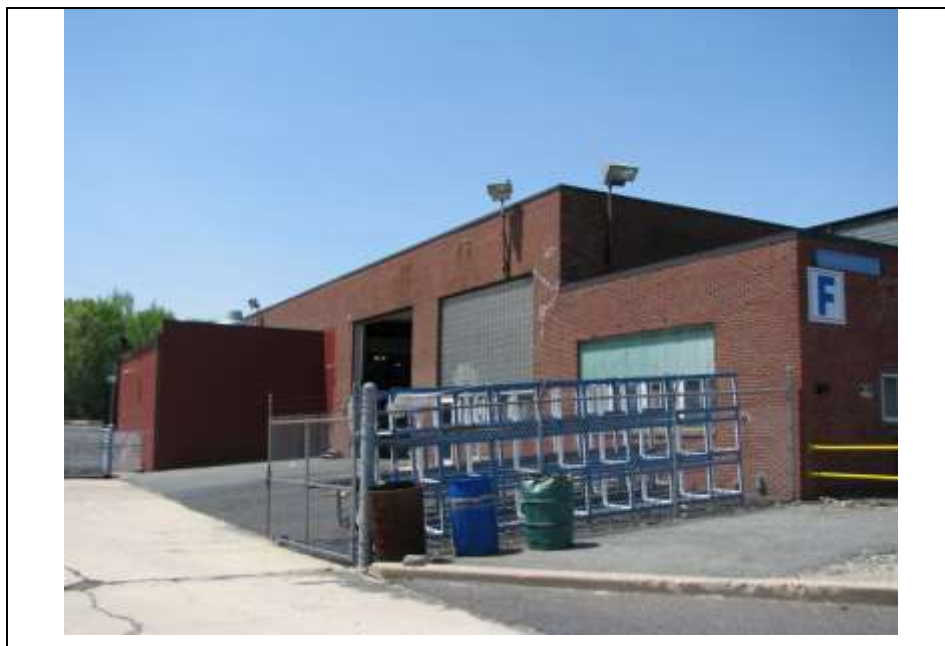
Photograph 16: Southeast elevations of the 1948 Unit F. Looking southwest (May 2014).

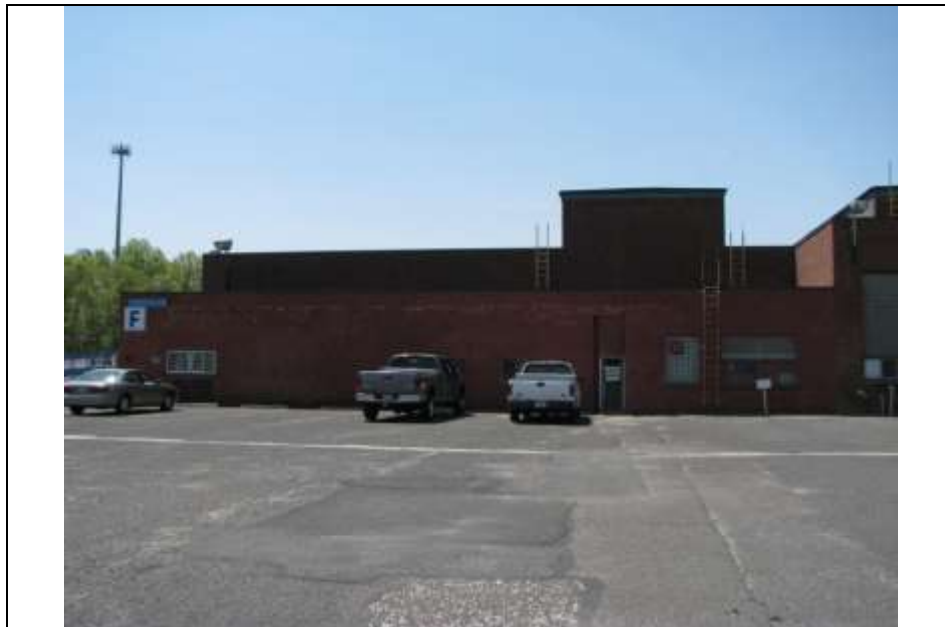
Photograph 17: Southeast end of the northeast elevations of the 1948 Unit F. Looking southwest (May 2014).

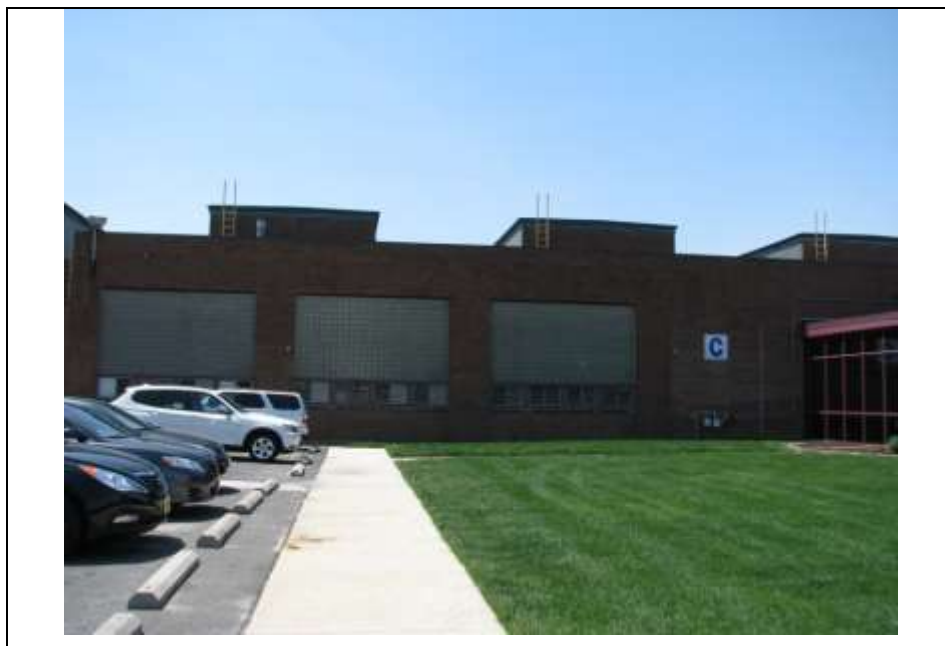
Photograph 18: Northwest end of the northeast elevation of the 1948 Unit F. Looking southwest. Note the letter C shown in this view refers to the adjacent office, the edge of which is visible at far right (May 2014).

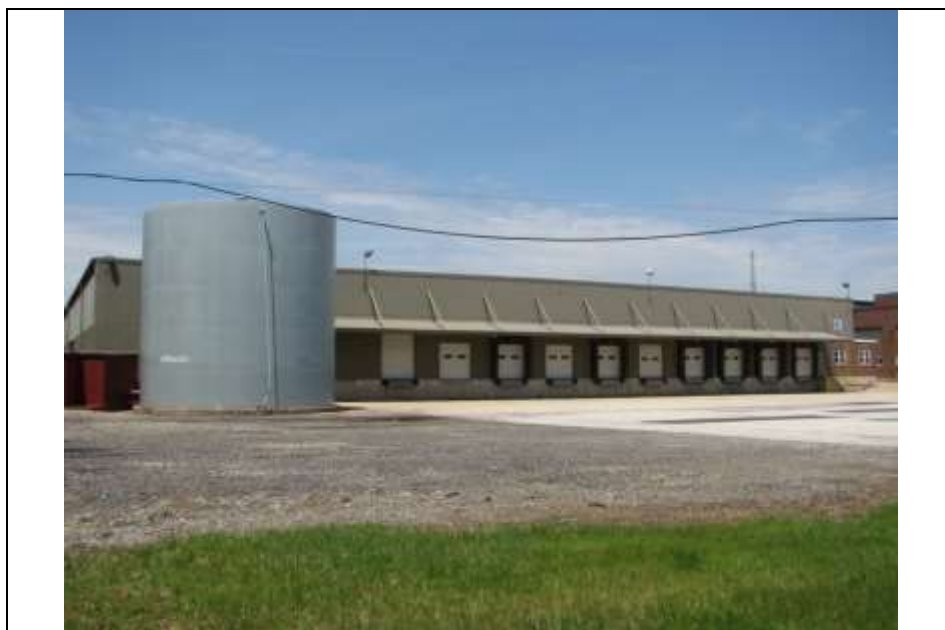
Photograph 19: Southeast elevation of the *circa*-1953 Unit K. Looking northwest. The *circa*-1953 water tank is also shown at left (May 2014).

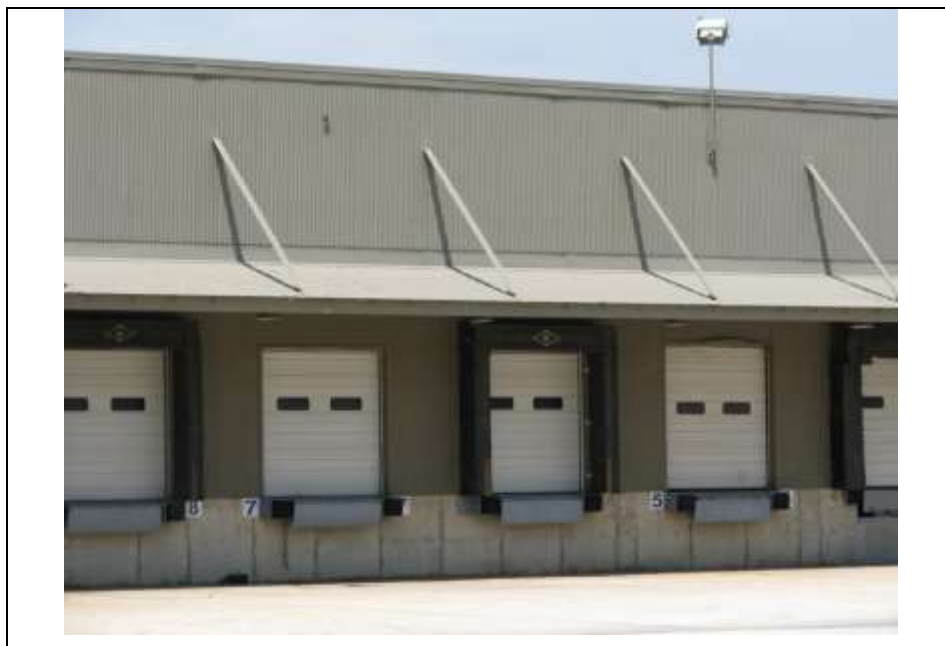
Photograph 20: Detail of southeast elevation of the *circa*-1953 Unit K, showing the shipping bays with modern garage doors. Looking northwest (May 2014).

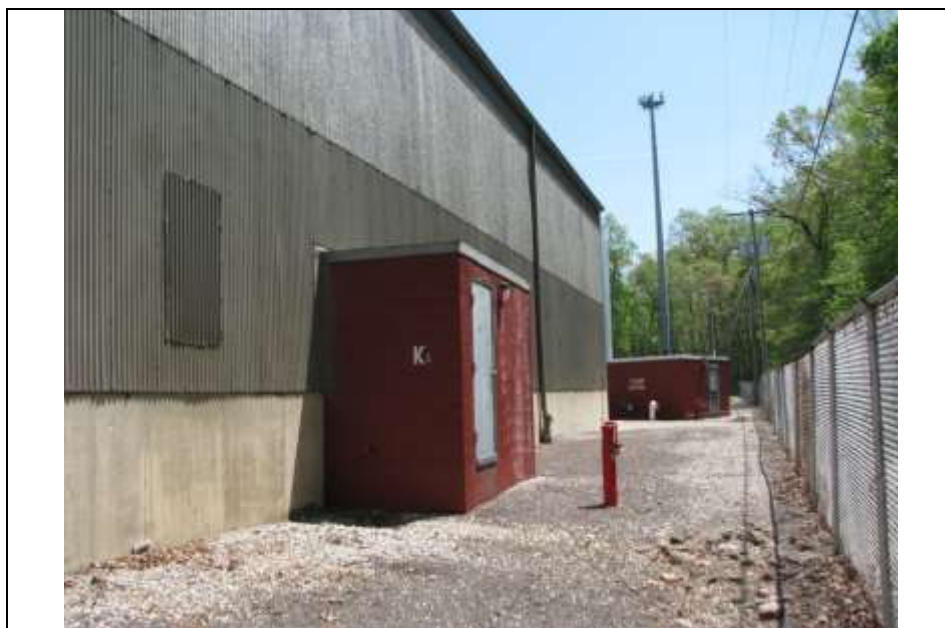
Photograph 21: Partial view of the southwest elevation of the *circa*-1953 Unit K. The *circa*-1953 fire pump house is visible in the background. Looking southeast (May 2014).

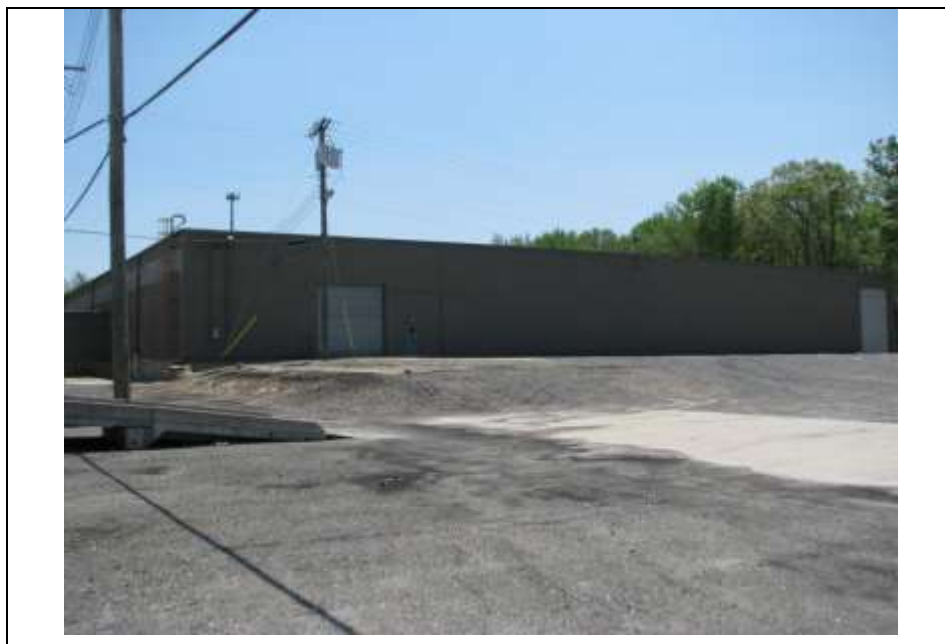
Photograph 22: Northwest elevation of the *circa*-1953 Unit K. Looking southeast (May 2014).

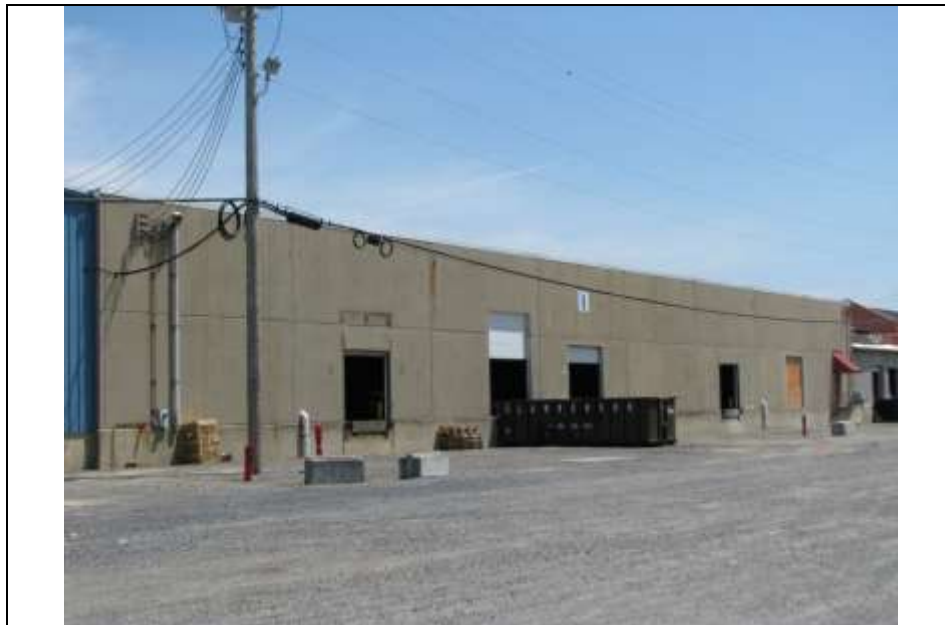
Photograph 23: Southwest elevation of the *circa*-1960 Unit I. Looking east (May 2014).

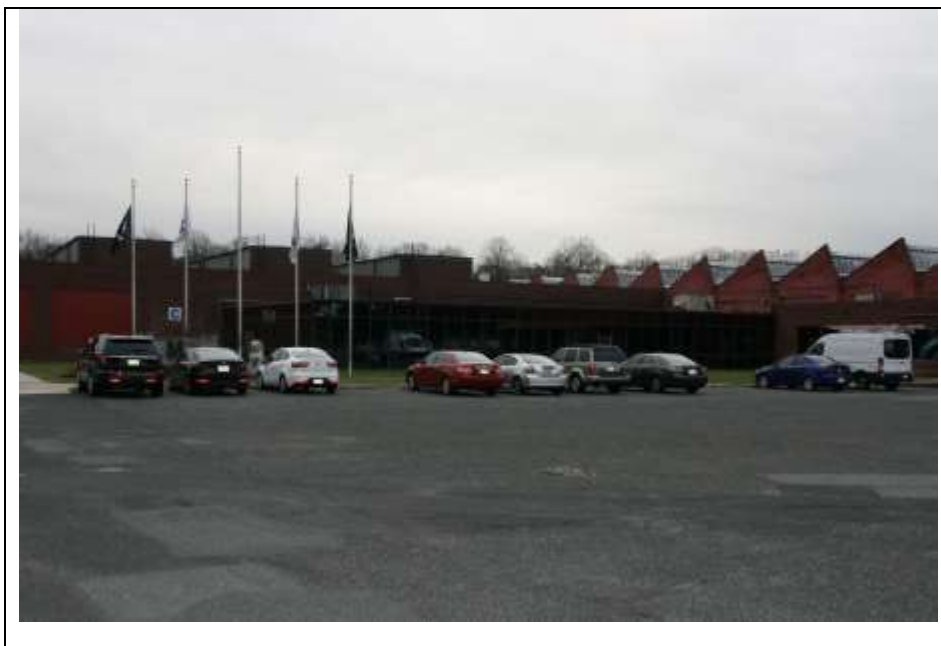
Photograph 24: Overview of the *circa*-1967 office (Unit C). The sawtooth roof of the 1918 manufacturing plant and storehouse is visible at right-background, and the monitor roof of Unit F is visible at left-background. Looking west (November 2018).

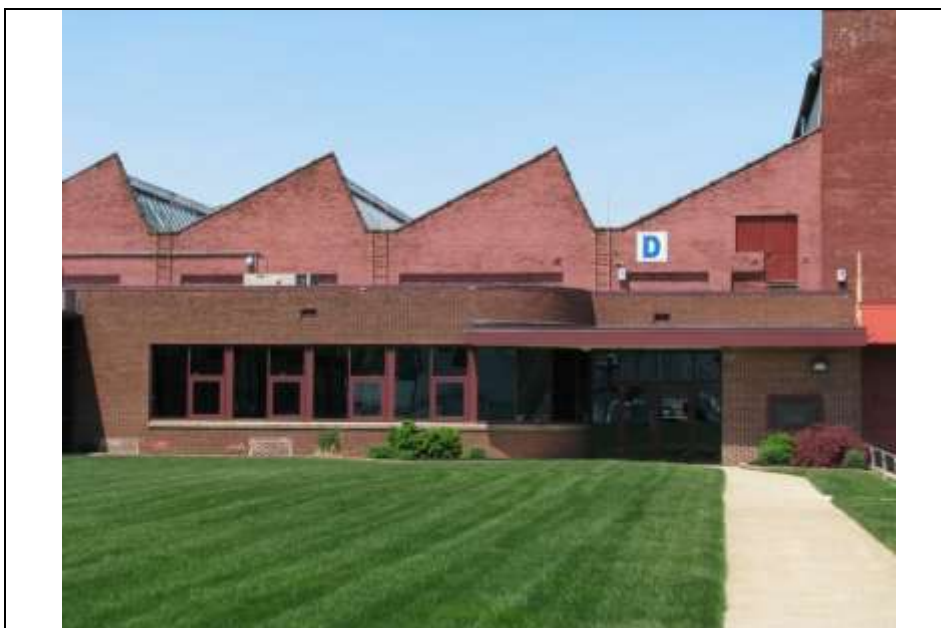
Photograph 25: Detail of southeast elevation of the *circa*-1967 office (Unit C). Looking northwest (May 2014).

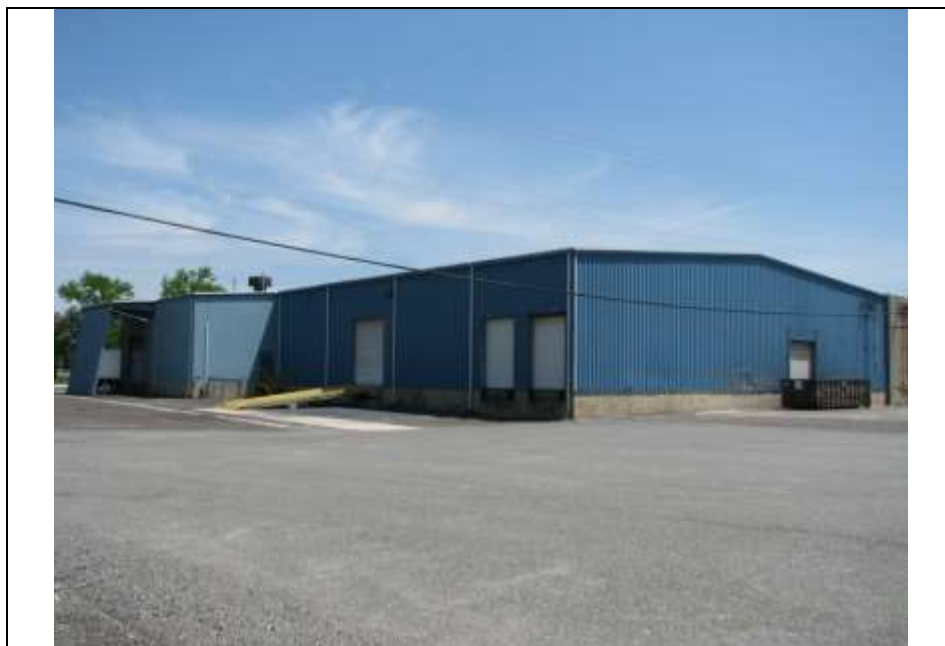
Photograph 26: Northwest and southwest elevations of the *circa*-1980 Unit J. Looking east (May 2014).

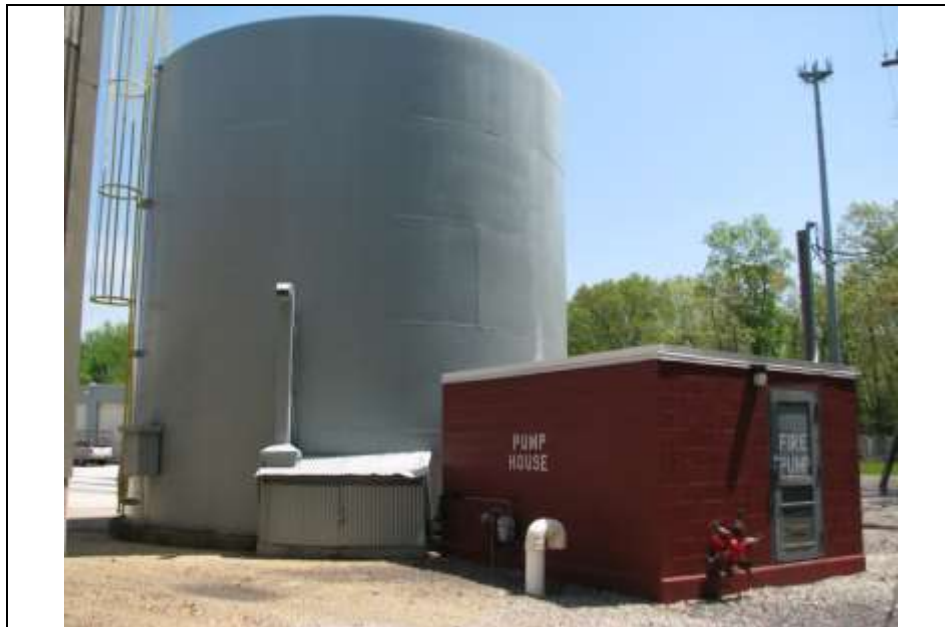
Photograph 27: Overview of the *circa*-1953 fire pump house and water tank located adjacent to the plant's south corner. Looking east (May 2014).

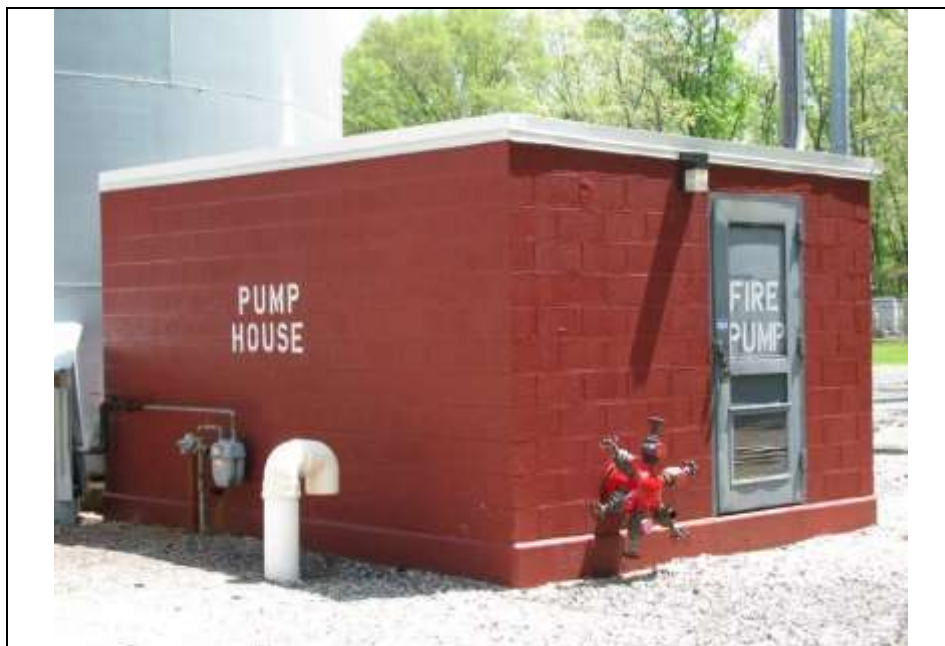
Photograph 28: Northwest (side) and southwest (front) elevations of the *circa*-1953 fire pump house. Looking east (May 2014).

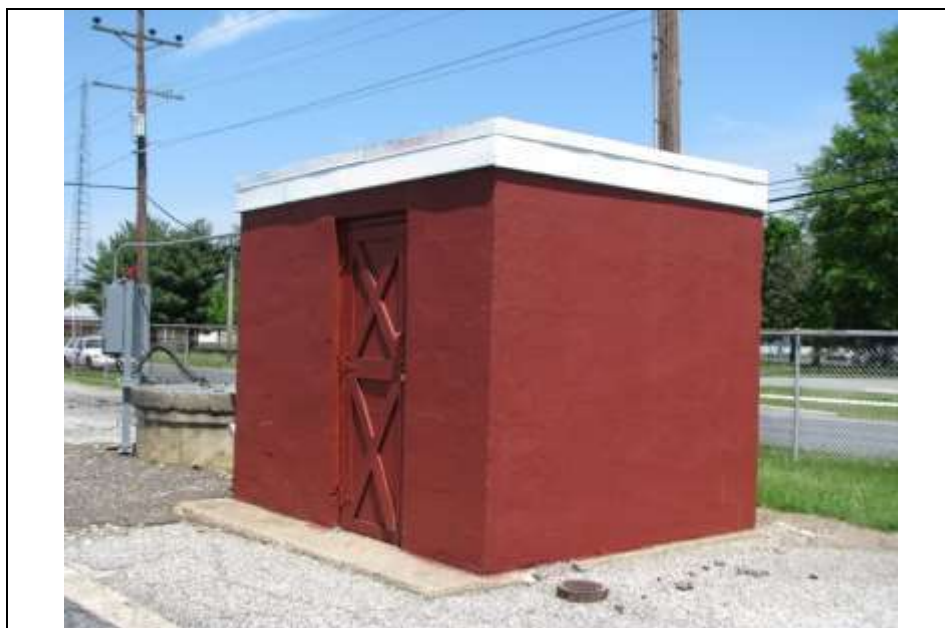
Photograph 29: Southwest (front) and southeast (side) elevations of the *circa*-1960 utility meter building. Looking north (May 2014).

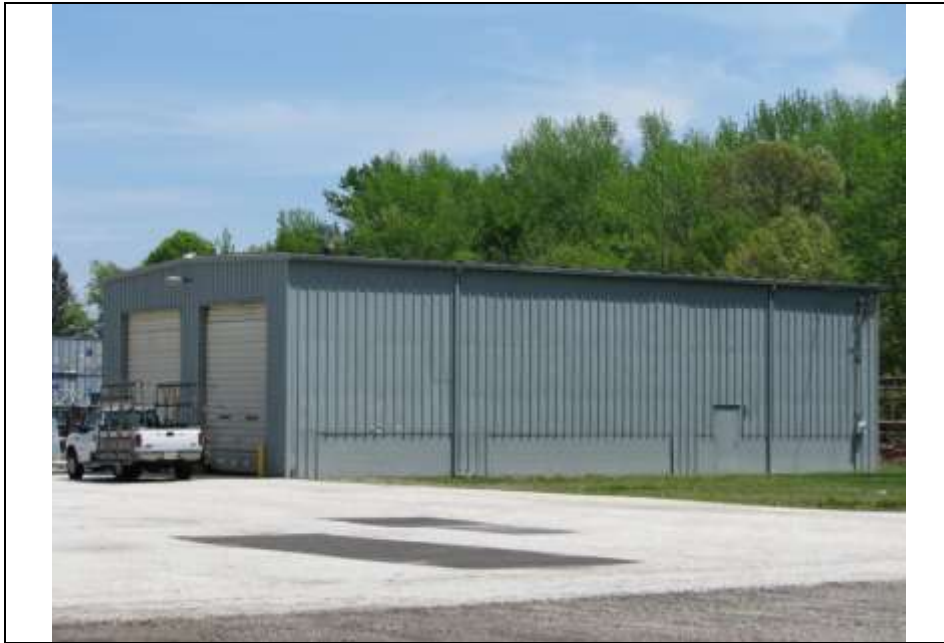
Photograph 30: Northwest (front) and southwest (side) elevations of the *circa*-1980 garage. Looking northeast (May 2014).

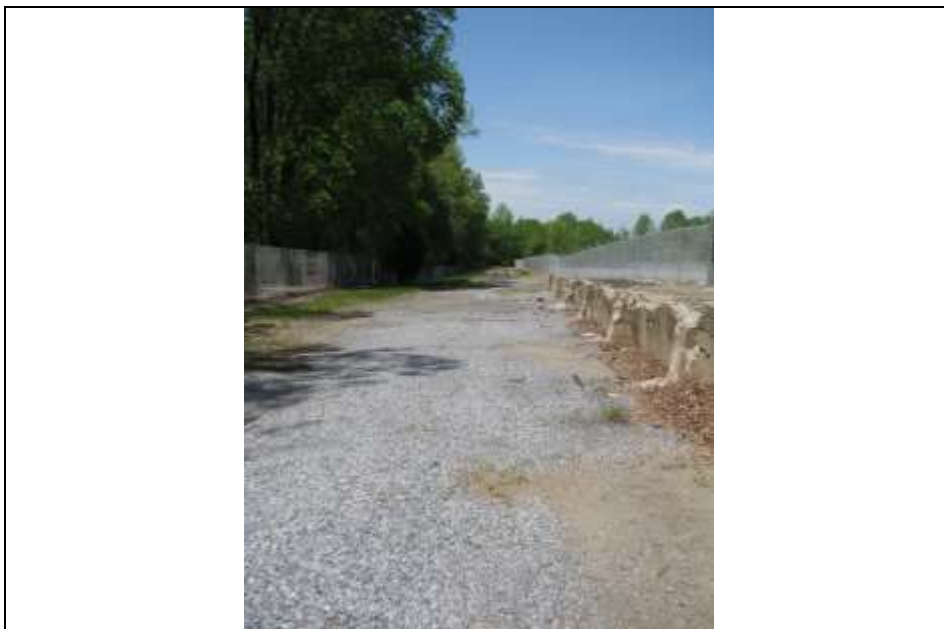
Photograph 31: Partially buried *circa*-1953 railroad siding located just inside the southwest property line (the rails are visible in the background). It appears that this line, which extended from the West Jersey Railroad's Bridgeton Branch, was installed to serve Unit K (ca. 1953), as it is aligned with an opening in the building's northwest elevation. Looking northwest (May 2014).

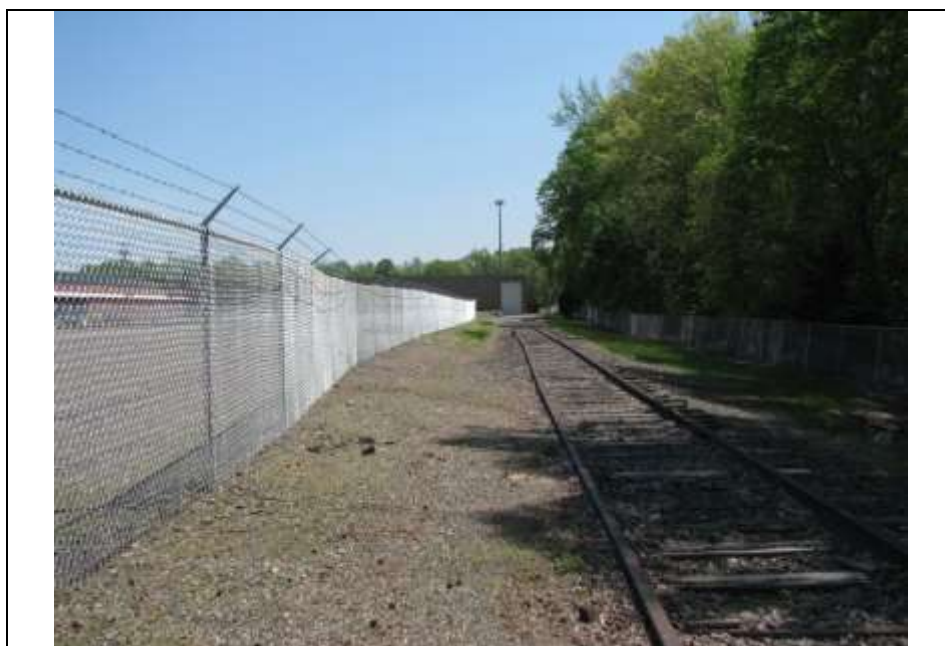
Photograph 32: Partially buried *circa*-1953 railroad siding located just inside the southwest property line. It appears that this line, which extended from the West Jersey Railroad's Bridgeton Branch, was installed to serve Unit K (ca. 1953), as it is aligned with an opening in the building's northwest elevation (visible at right background). Looking southeast (May 2014).

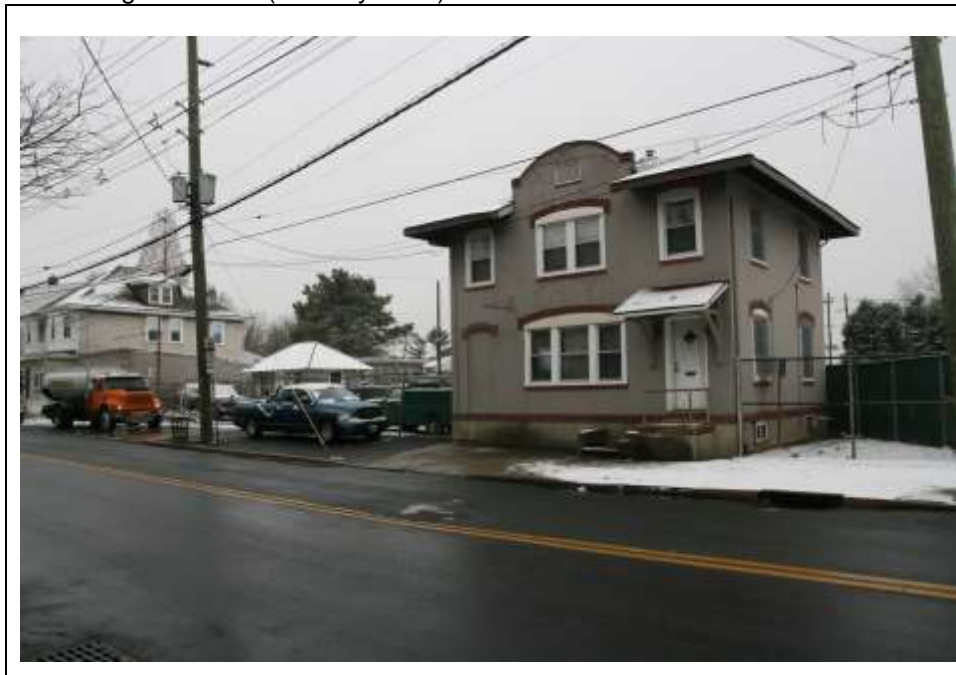
Photograph: Northeast (façade) and northwest (side) elevations of the former Gallagher Brothers Inc. property at 806 Market Street. Looking southeast (January 2019).

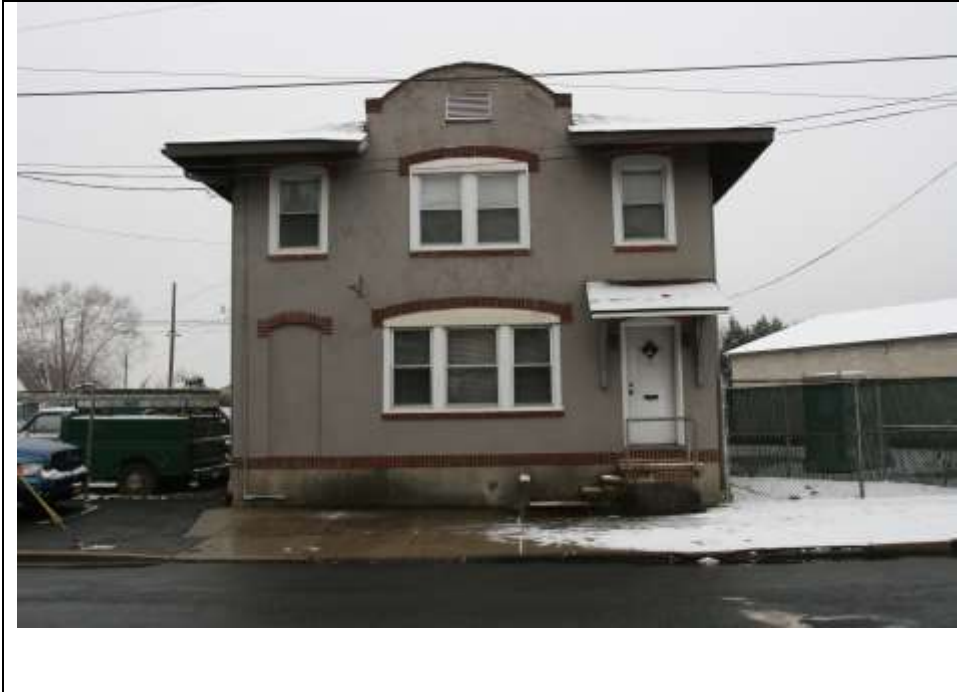
Photograph 2: Northeast elevation (façade) of the former Gallagher Brothers Inc. office at 806 Market Street.. Note the infilled entrance at the left. Looking southwest (January 2019).

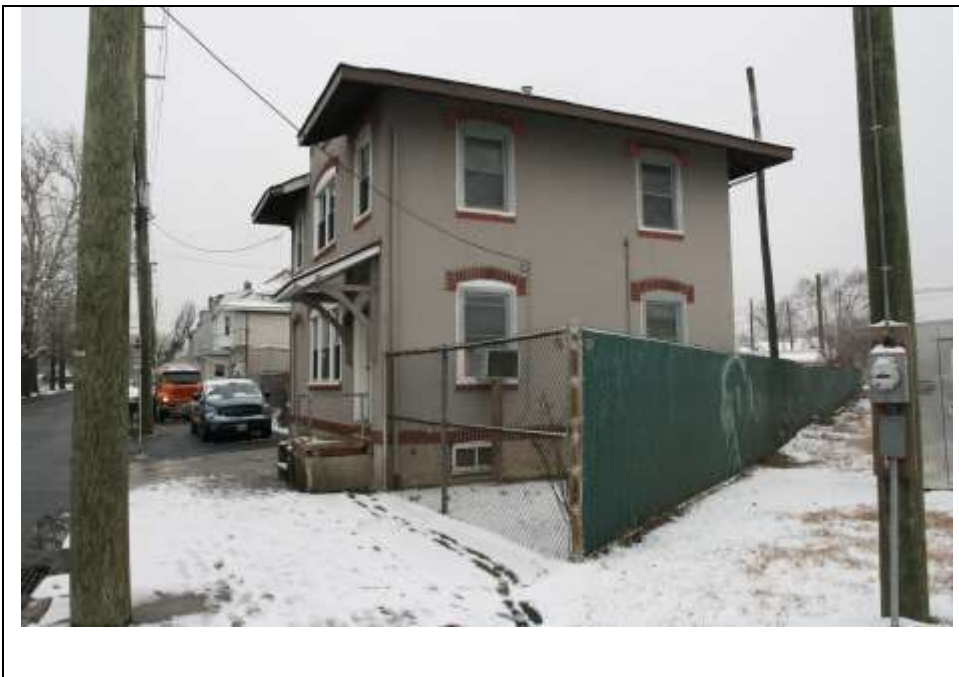
The northwest (side) elevation has two bays on both the first and second floors; each bay contains one typical window (Photographs 1 and 3). In the foundation under the north bay is a modern, two-light, wood, fixed window.

Photograph 3: Northeast (facade) and northwest (side) elevations. Looking southeast (January 2019).
