- 77 and 78 East Center Street, Woodbury City, Gloucester County
- 856 Main Street, Mantua Township, Gloucester County
- Tyler's Mill Road Bridge over Chestnut Branch, Mantua Township, Gloucester County
- 628-634 Kaighns Avenue (Victory Garage), Camden City, Camden County

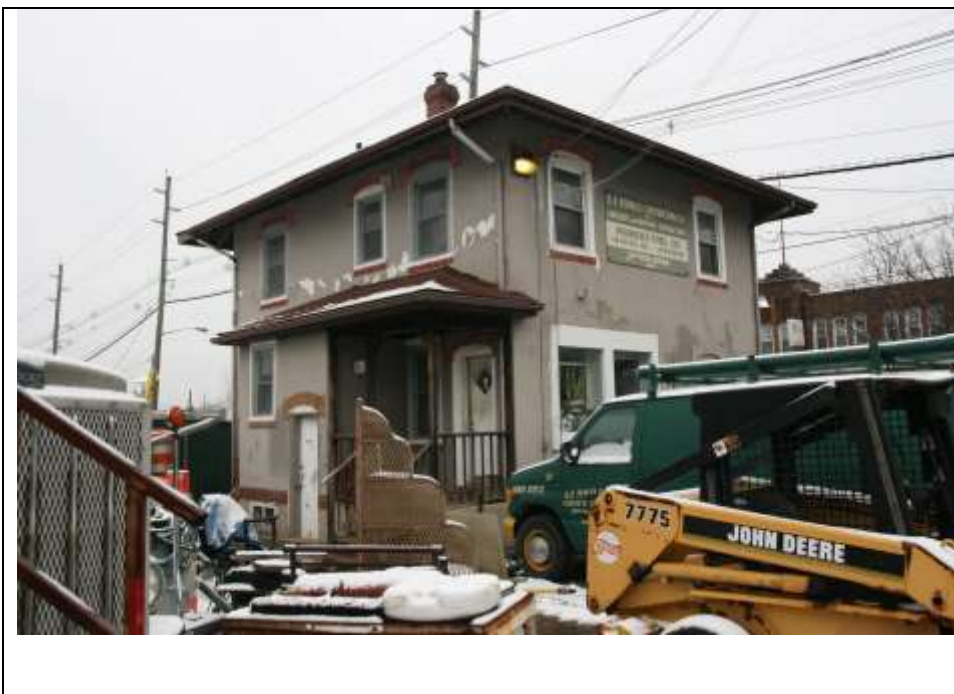
The southwest (rear) elevation has four bays on the first floor and three bays on the second floor (Photograph 4). The west bay on the first floor contains one typical window, although it does not have a brick lintel. The second bay from the west contains a modern metal door with a brick lintel that extends into the foundation; the brick used for the lintel is different than the other brick, indicating the doorway is likely a later modification. The third bay from the west has one typical window, and the eastern bay contains a modern metal door. The first floor is framed by a hipped roof porch, the western part of which appears to have been enclosed based on the different brick. The eastern part of the porch has a concrete deck and wood posts to support the roof. On the second floor, the west and east bays each have a typical window, the central bay has a slightly smaller version of the typical window. On the south slope of the roof is an interior brick chimney with corbeling. In the foundation is a two-light, wood, fixed window and a modern metal door at floor level, which leads to the basement.

The southeast (side) elevation has two bays (Photograph 4). The south bay has a pair of one-over-one, vinyl, fixed windows with a vinyl surround. The north bay has an infilled door opening with an arched brick lintel. Both of the bays on the second floor have typical windows.

Photograph 4: Southwest (rear) and southeast (side) elevations. Looking northwest (January 2019).

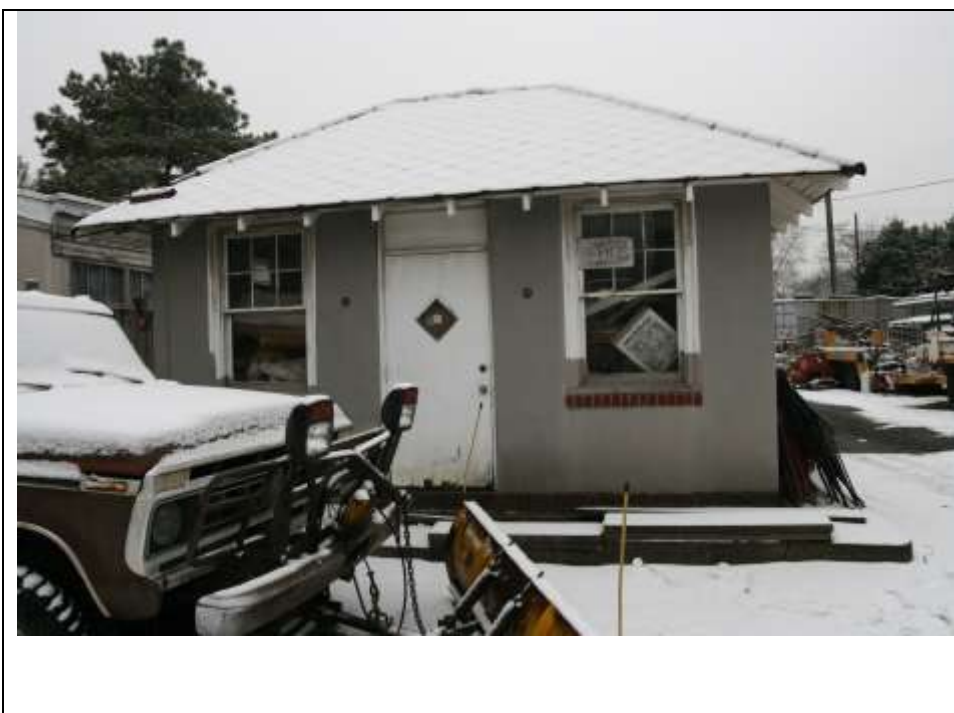
Photograph 5: Northeast (front) elevation of the former Gas Station. Looking southeast (January 2019).

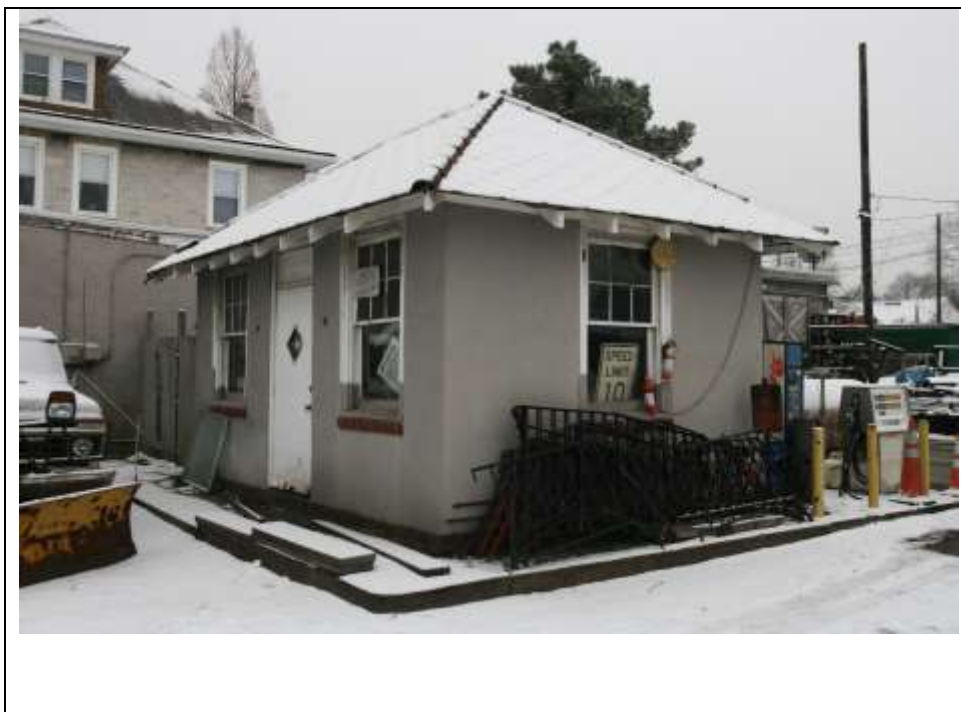
Photograph 6: Northeast (façade) and northwest (side) elevations of the Gas Station. Looking southeast (January 2019).

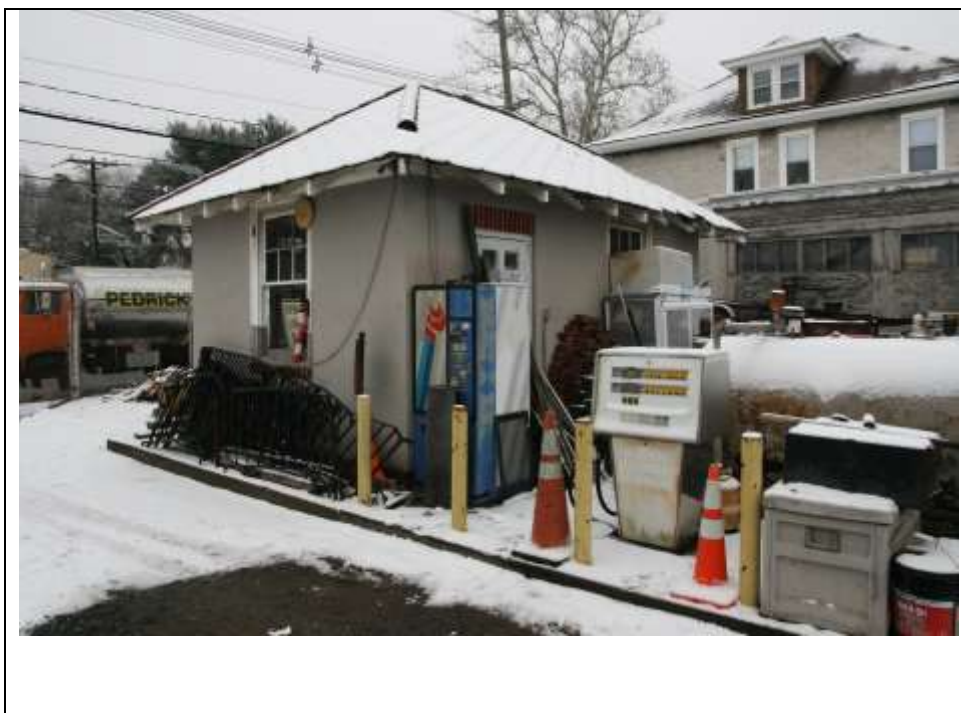
Photograph 7: Northwest (side) and southwest (rear) elevations of the Gas Station. Looking northeast (January 2019).

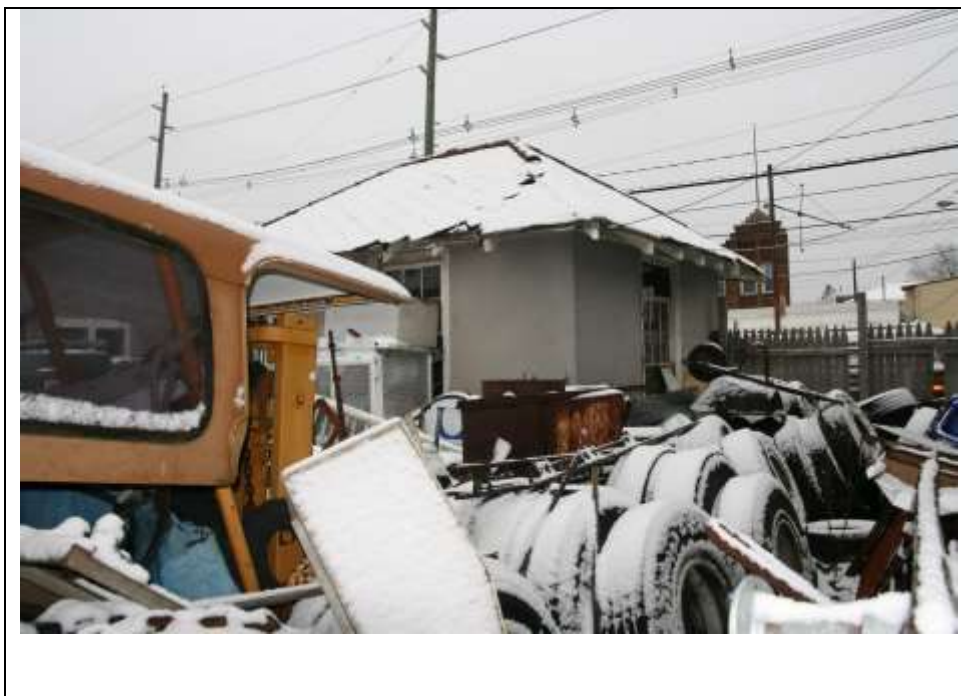
Photograph 8: Southwest (rear) and southeast (side) elevations of the Gas Station. Looking northwest (January 2019).

Exterior Description: The *circa*-1930 gas station is located approximately 50 feet east of the office building. The one-story, wood-framed building, is clad with stucco and supported by a brick foundation on a concrete pad. It has a hip roof with open eaves and exposed rafter tails, and is covered with terracotta tiles. Window openings throughout the building contain six-over-one, wood, double-hung sash window with a brick sill, unless otherwise noted. The northeast (front) elevation has three bays (Photographs 5 and 6). The east and west bays each have a typical window. The central bay has a modern wood door with a diamond light, and an infilled transom opening above. The northwest (side) elevation has one bay with a typical wood window (Photographs 6 and 7). The southwest (rear) elevation has two bays (Photograph 7). The west bay has a two-light over a four-panel wood door, with a brick lintel. The east bay has what looks to be a typical window; the lower pane is obstructed from view. The southeast (side) elevation has one bay with a typical wood window (Photograph 8).

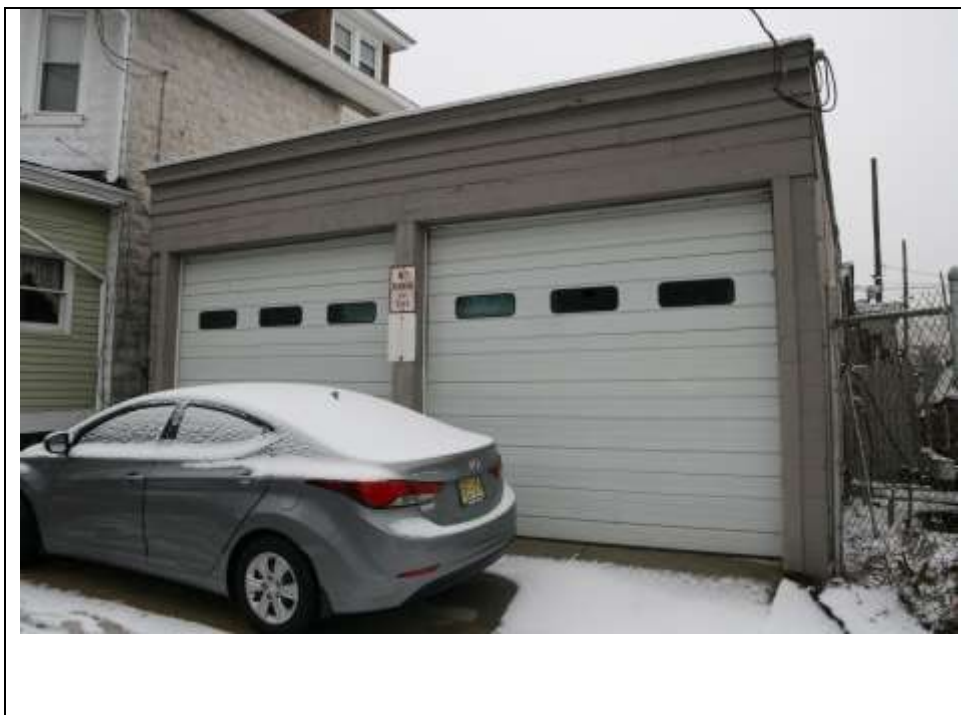
Exterior Description: The *circa*-1930 garage/workshop is located approximately 85 feet east of the office building. The one-story, concrete block and plywood structure has two modern metal rolling garage doors on its northeast (front) elevation (Photograph 9). The northwest (side) elevation has concrete block walls to the north and plywood walls to the south (Photographs 10-13). The concrete block portion of the northwest elevation does not have any openings (Photograph 11); this portion is covered by a butterfly roof, with the "V" visible on the northwest and southeast elevations. The plywood section of the northwest elevation has four bays and is topped by a shed roof (Photographs 12 and 13). The first bay (from the north) has two sets of three, one-light, wood, fixed windows, below which is a one-light, wood, fixed window. The second bay has two sets of three, one-light, wood, fixed windows and a pair of one-light, wood, fixed windows. Below the middle set of windows is a one-light, fixed, wood window. The third bay from the north has a plywood door with a single light, and a three-light transom. The final bay protrudes slightly beyond the rest of the northwest elevation. This bay has two large sliding wood doors, each with two central lights and two cross panels (Photograph 13). The southwest (rear) elevation is constructed of concrete blocks, with no discernable features (Photograph 10). The southeast (side) elevation was not accessible during the survey.

Photograph 9: Northeast (front) elevation of the Garage/Workshop. Looking southwest (January 2019).

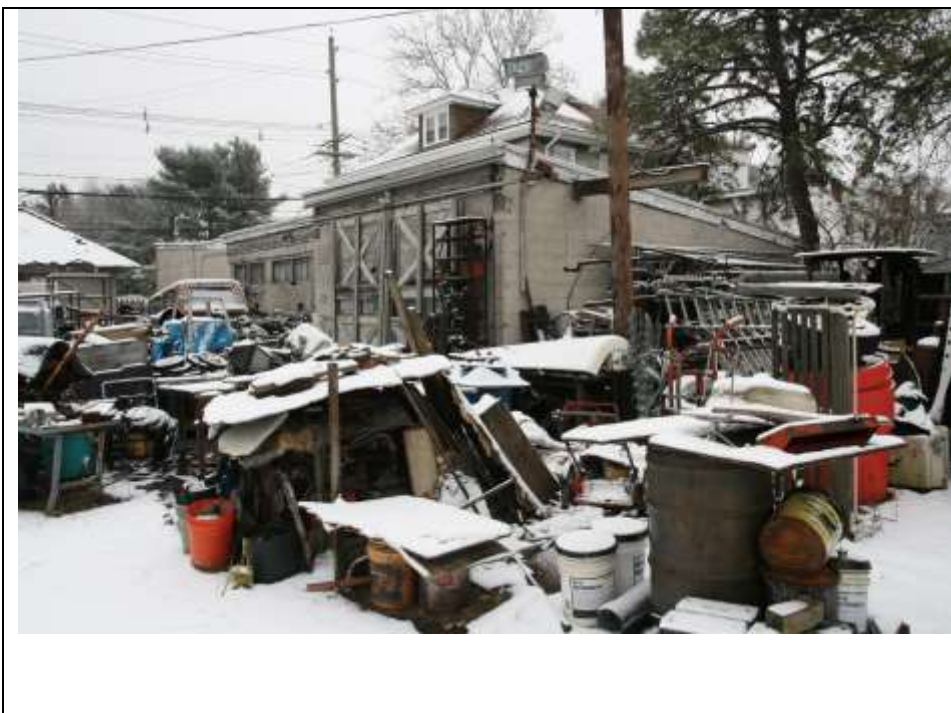
Photograph 10: Northwest (side) and southwest (rear) elevations of the Garage/Workshop. Looking northeast (January 2019).

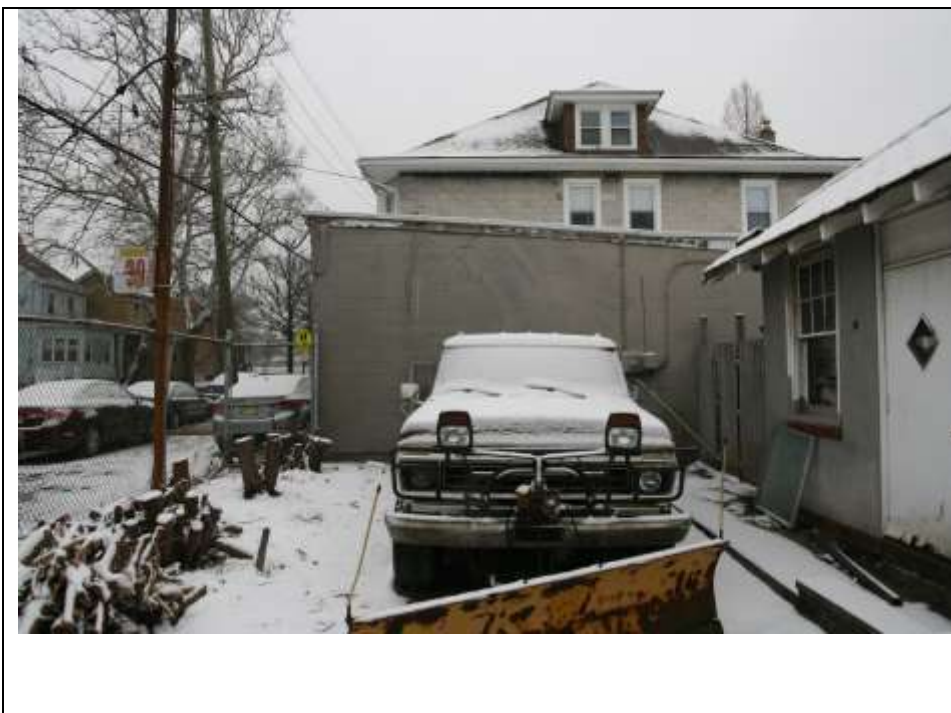
Photograph 11: North portion of northwest (side) elevation of the Garage/Workshop; note the concrete block construction. The façade of the gas station is visible on the right. Looking east (January 2019).

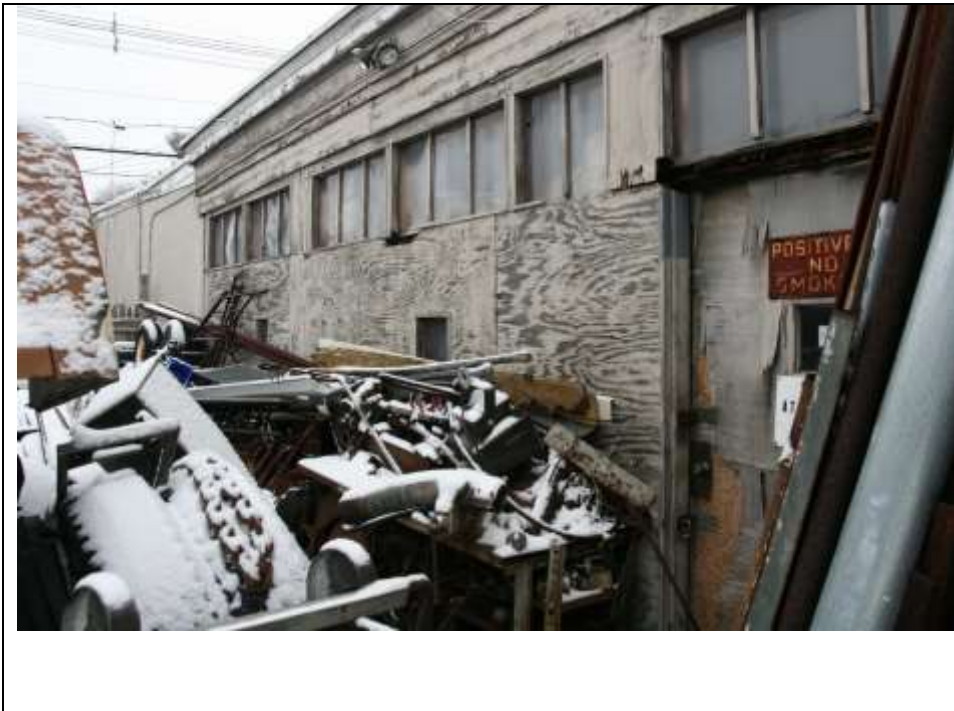
Photograph 12: Middle portion of northwest (side) elevation of the Garage/Workshop. Note the plywood construction. Looking northeast (January 2019).

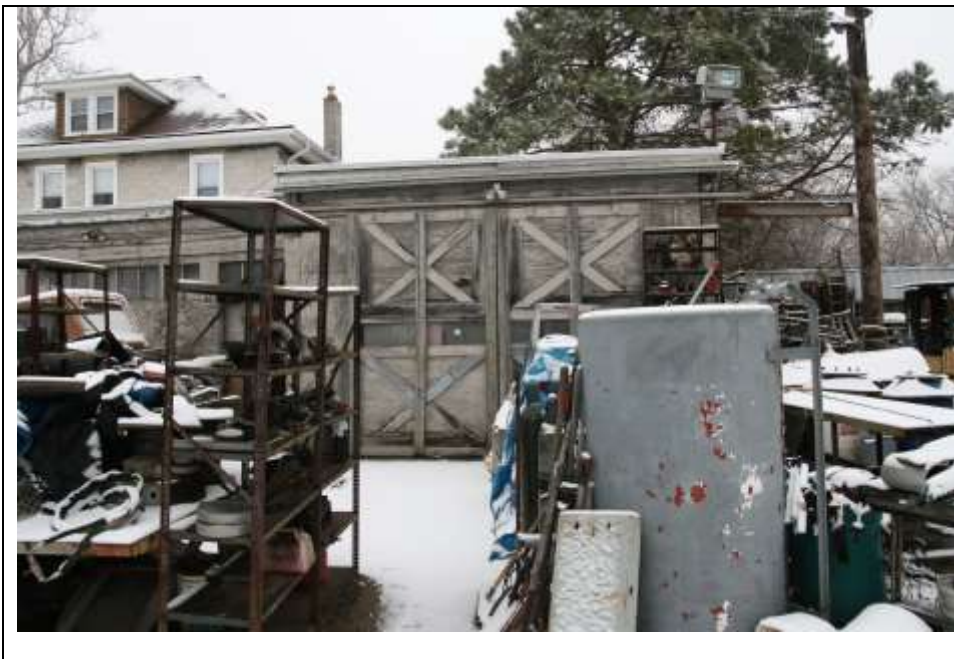
Photograph 13: Southern portion of northwest (side) elevation of the Garage/Workshop. Note the plywood construction. Looking east (January 2019).

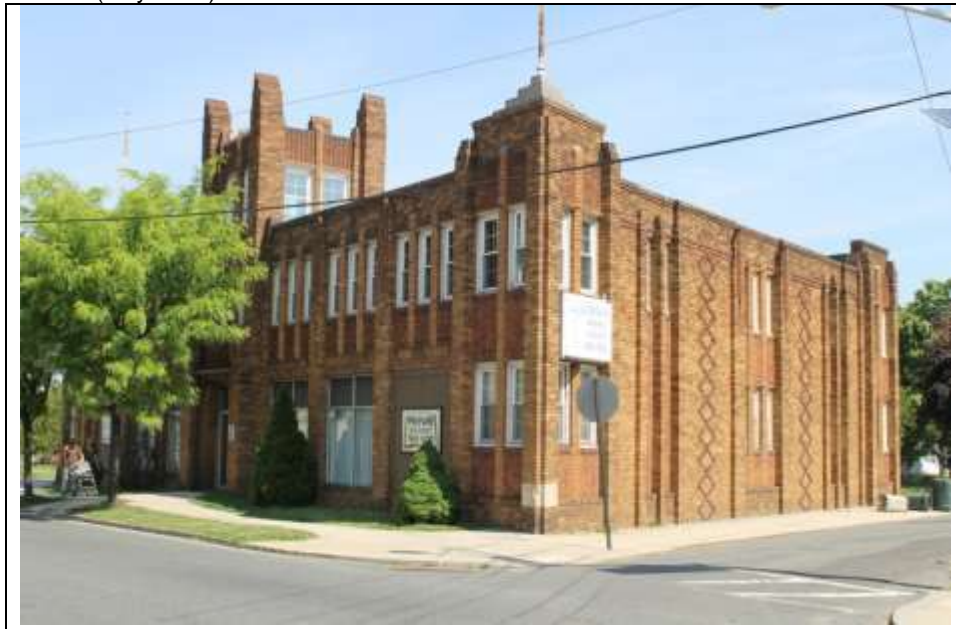
Photograph 1: South (front) and east (side) elevations of the former J.R. Quigley Company office and store at 811 Market Street. Looking northwest (May 2014).

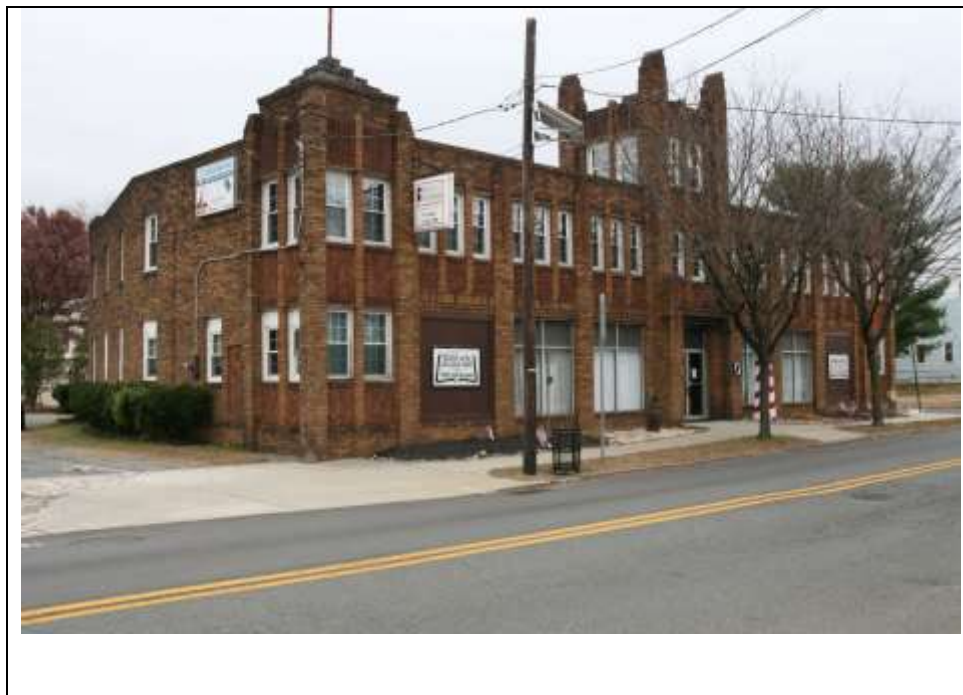
Photograph 2: West (side) and south (front) elevations of the former J.R. Quigley Company office and store at 811 Market Street. Looking east (November 2018).

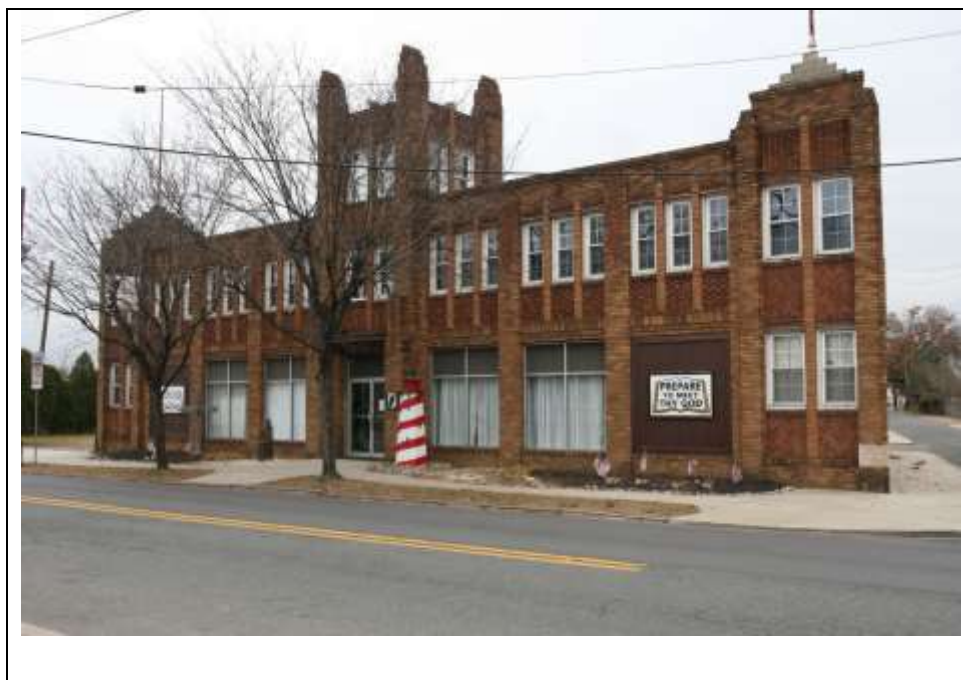
Photograph 3: South elevation (façade). Looking northwest (November 2018).

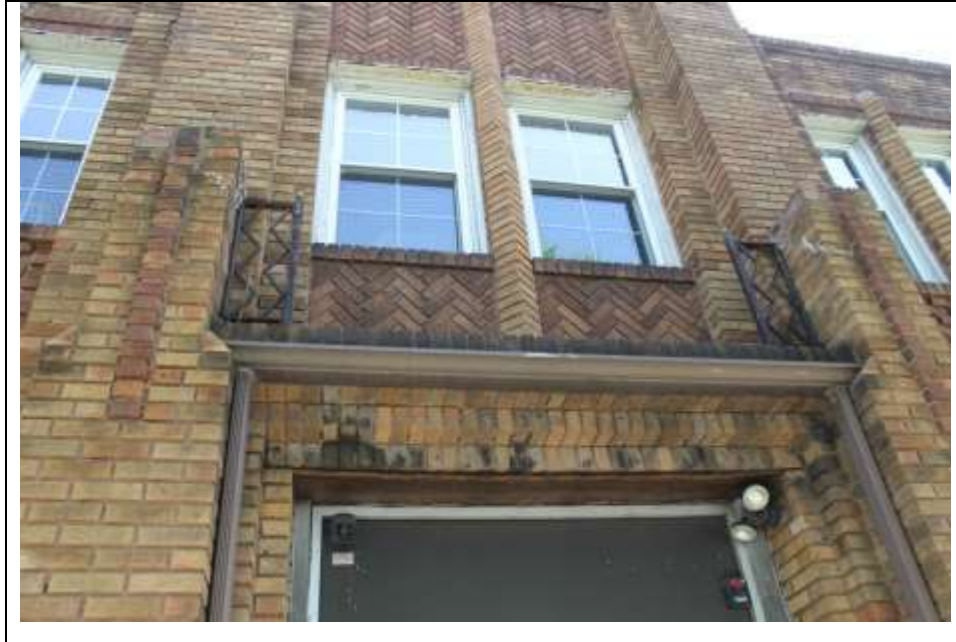
Photograph 4: Detail of brickwork and ironwork in the second story of the façade's central tower. Looking northeast (May 2014).

The only building on the property is a 1929 two-story, detached, Art Deco-style commercial building with a brick structural system (Photographs 1 through 12). The building has a trapezoidal footprint with its south elevation (façade) measuring approximately 90 feet wide and its north (rear) elevation measuring approximately 55 feet wide. The building is approximately 69 feet long. It rests on a brick foundation, and its brick exterior walls exhibit a Flemish stretcher bond pattern. The flat roof has parapets on each elevation. The windows are primarily vinyl, four-over-four, double-hung sash units with wood surrounds, brick sills, and brick lintels, except where noted below. Three towers are present, one centered in the façade and the others located at the southeast and southwest corners of the building. The parapet roof is stepped slightly higher at the northeast and northwest corners of the building, creating the look of towers at these corners as well. The east (street side) elevation of the northeast tower looks the same as the southeast and southwest (façade) towers; however, the other elevations of the towers at the rear corners of the building are not elaborately decorated. Art Deco stylistic features of the building include smooth wall surfaces,¹ decorative brickwork in chevron and other geometric patterns, and vertical towers (McAlester 2013:581). The building has a cornerstone at the southeast corner bearing the dates 1888 and 1929, representing the establishment of the J.R. Quigley Company (for which this building originally served as an office and store) and the construction date of the extant building respectively (Photograph 6). The building looks very much as it did in 1937, based on an illustrated J.R. Quigley Company catalog of that year (Figure 1) (J.R. Quigley Company 1937).

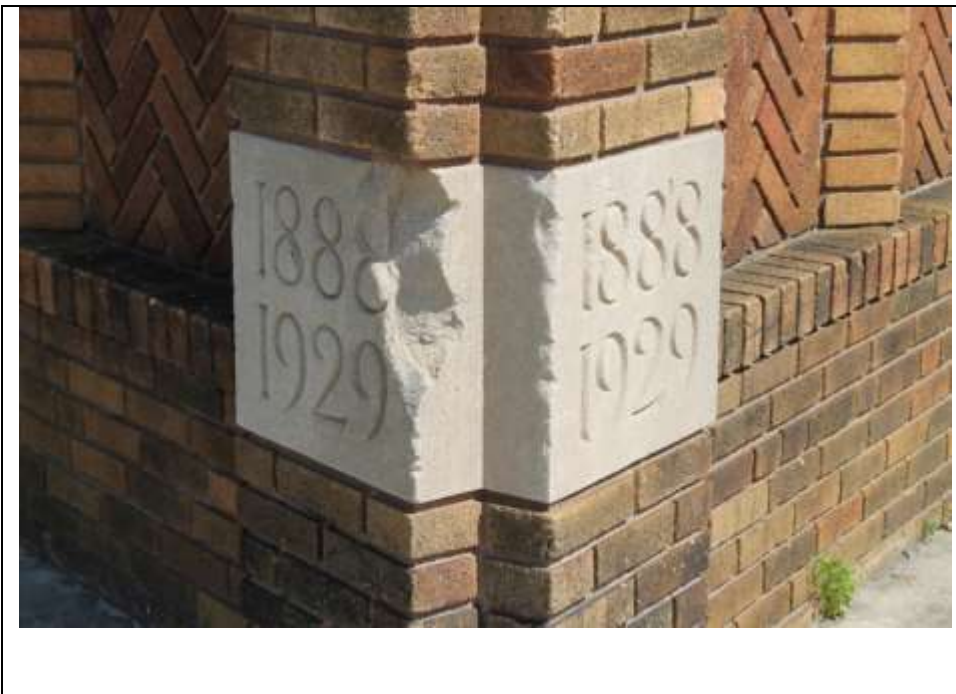
Photograph 5: Detail of the date stone at the building's southeast corner. The inscriptions 1888 and 1929 represent the year the J.R. Quigley Company was established and the year this building was erected, respectively. Looking north (May 2014).

The extant Art Deco-style building at 811 Market Street was constructed in 1929, based on its date stone, replacing the dwelling and warehouse that had previously stood at the northwest corner of the intersection of Market Street and Washington Avenue. The new building was labeled as an office and store on the 1930 Sanborn map (Figure 2). Aside from the addition of the 1929 building, the J.R. Quigley Company complex remained relatively unchanged in 1930. One notable change was the expansion of the warehouse on the east side of Washington Avenue (present-day 136 Washington Avenue; this building is currently on a separate tax parcel from 811 Market Street) (Sanborn Map Company 1930).

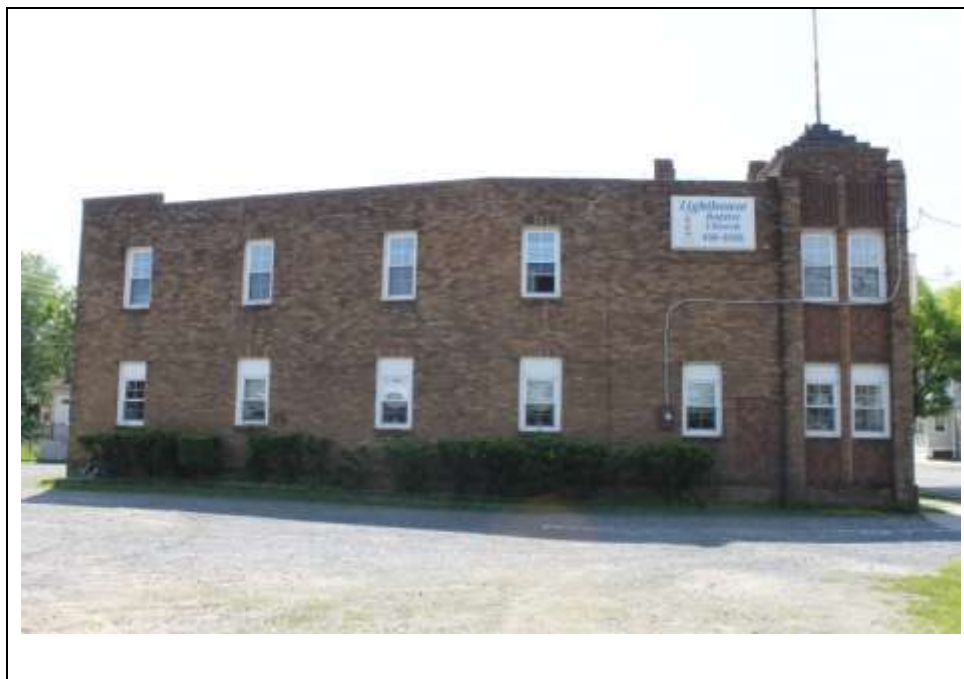
Photograph 6: West (side) elevation. Looking southeast (May 2014).

The west (side) elevation consists of six bays, all of which contain window openings (Photographs 7 through 8). Bays one through five (counted from north to south) each contain single, vertically-aligned typical windows in each story. Bay six only contains a first-story window. A former pedestrian entrance between bays six and seven has been filled with chevron-patterned brickwork. Bay seven is comprised of the southwest corner tower, and its openings, windows, and decorative features are the same in this elevation as previously described on the facade. The first-story windows in all bays of the west elevation are smaller than their openings, and wood panels fill the spaces above the windows.

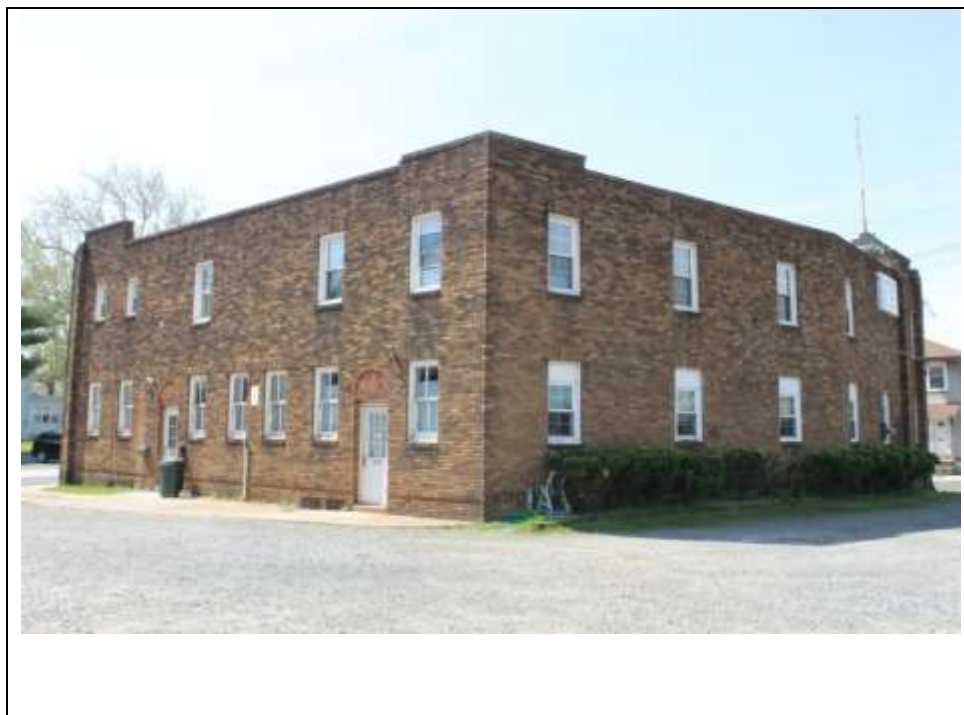
Photograph 7: North (rear) and west (side) elevations. Looking south (May 2014).

The north (rear) elevation consists of nine bays (Photographs 8 through 9). Bays three and eight (counted from east to west) contain entrances in the first story and lack second-story openings. The entrances contain modern replacement doors and are topped by faux arches framed by brick headers and filled with chevron-patterned brickwork. The remaining bays contain windows. Bays five and six have windows in the first story only; the others

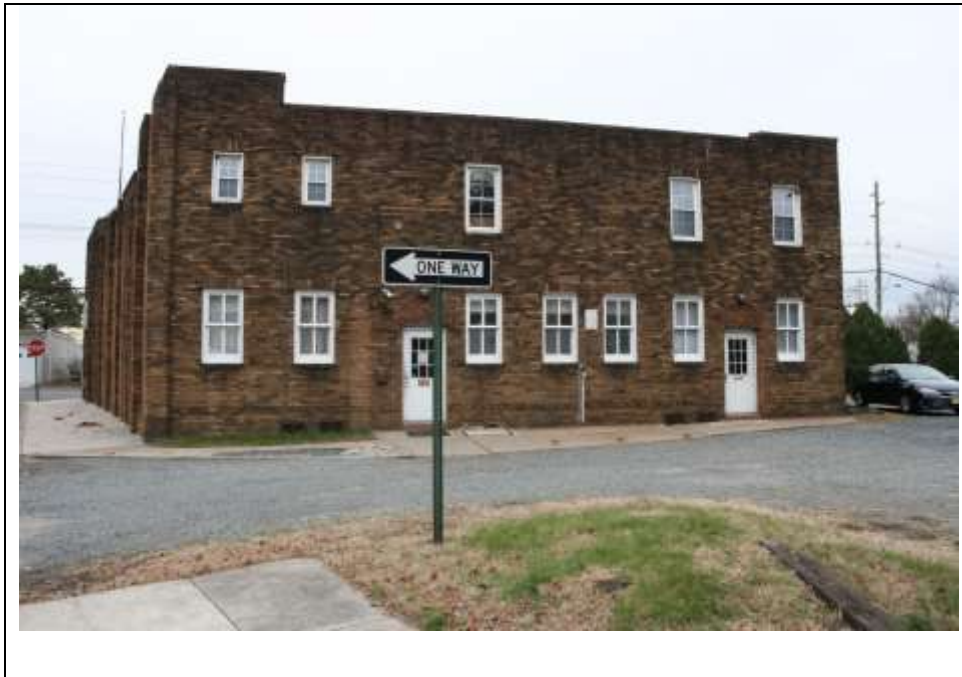
Photograph 8: North (rear) elevation. Looking southwest (November 2018).

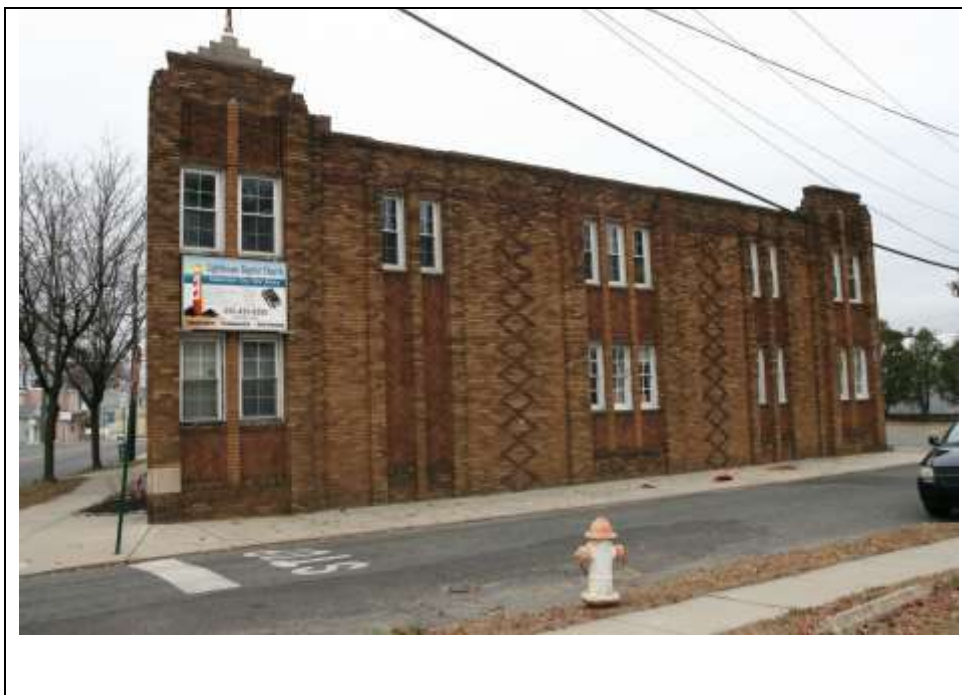
Photograph 9: East (side) elevation. Looking northwest (November 2018).

The east (side) elevation consists of seven bays separated by brick pilasters (Photographs 9 through 10). Bays one and seven (counted from south to north) are comprised of the southeast and northeast corner towers respectively, and their openings, windows, and decorative features are the same in this elevation as previously described for the corner towers in the façade. Bays two and six are similar to one another, containing a central vertical pilaster that further subdivides the bays. Bay two has two typical windows in the second story, divided by the central pilaster. The area below the windows is occupied by flat, chevron-patterned brickwork. Bay six is the same, except that it has two wood, four-over-four, double-hung sash windows in the first story. Bays three and five do not contain any openings, but instead feature a central, vertical ribbon of raised brickwork formed by protruding headers assembled into a repeated diamond-shaped pattern. Bay 4, the central bay, contains three window openings in both stories, which are vertically separated by bands of angular, protruding brickwork (as described on the façade). Flat, chevron-patterned brickwork is present beneath all window openings. The first-story windows are wood, four-over-four, double-hung sash types, and the second-story windows are typical replacement units.

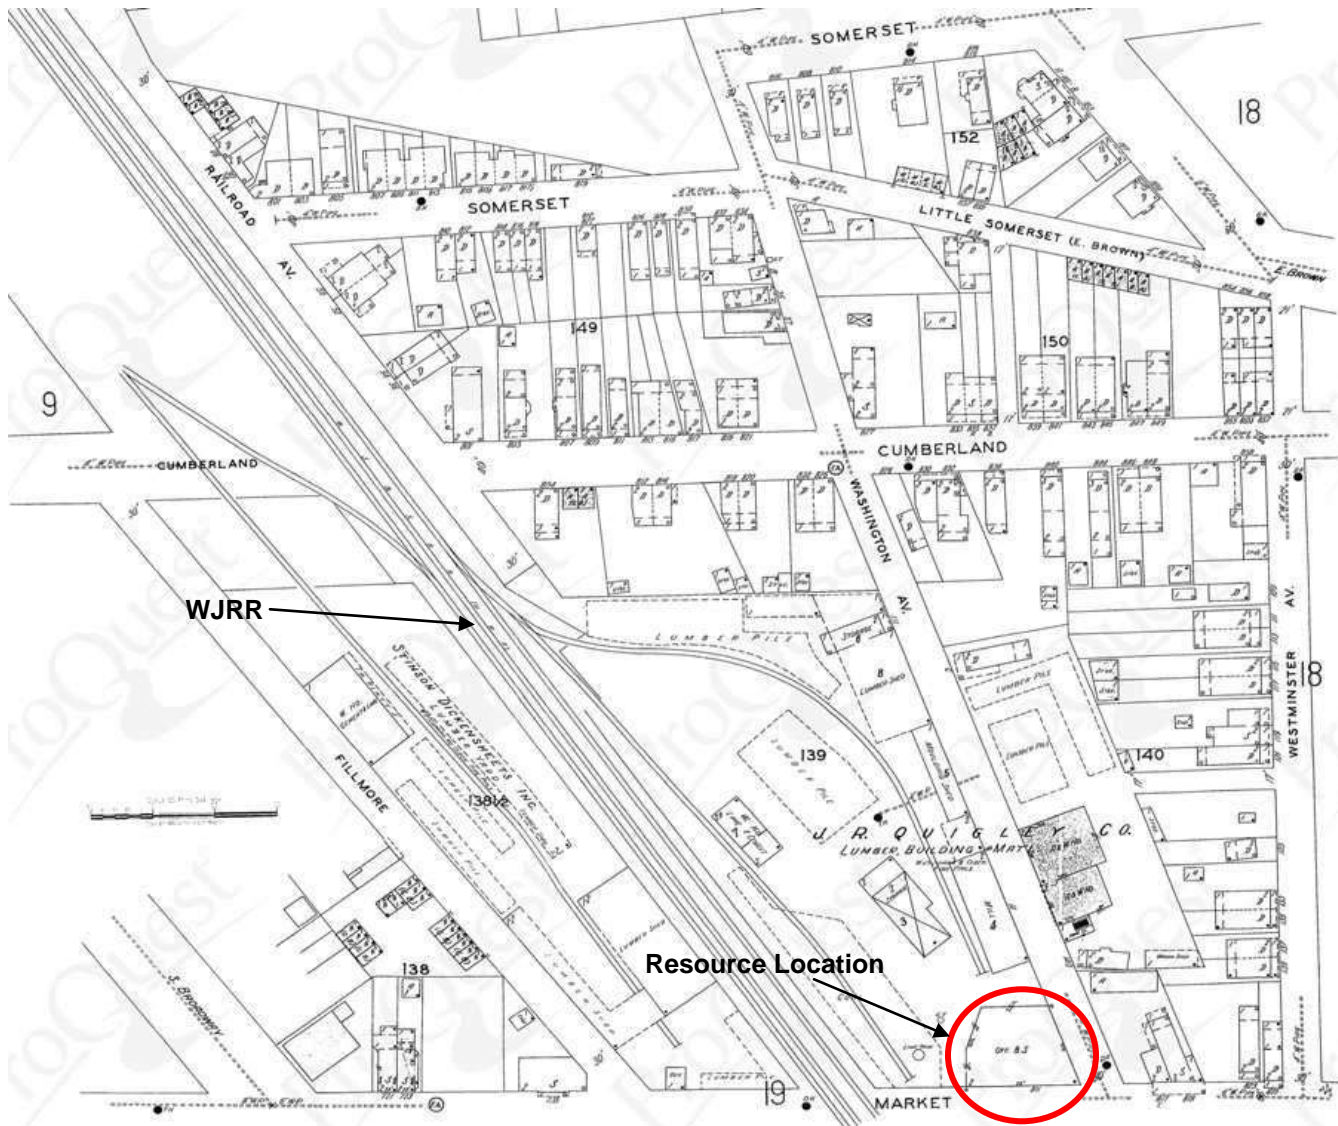
Figure 2. 1930 Sanborn map of Gloucester City showing the former J.R. Quigley Company office and store (811 Market Street) in context. Most of the other buildings associated with the J.R. Quigley Company complex are no longer extant, with the exception of a *circa*-1920-25 warehouse shown on the east side of Washington Avenue (present-day 136 Washington Avenue) and a *circa*-1950 garage/warehouse (present day 101 Washington Avenue) that is not depicted in this image. Note the proximity to the former WJRR tracks and the two sidings (no longer present) that historically served the complex.

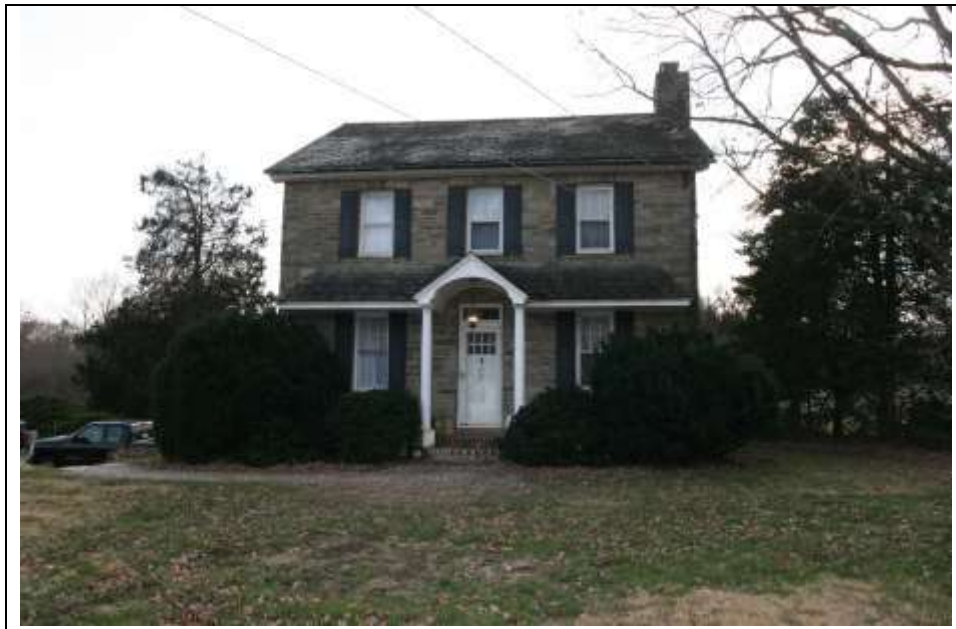
Photograph 1: Northeast elevation (façade) of dwelling at 856 Main Street. Looking southwest (December 2018).

The primary building is a single-family, detached, two-story, Colonial Revival-style dwelling of wood frame construction with rough-cut, coursed stone veneer exterior wall cladding (Photographs 1 to 4). The dwelling rests on a stone-clad, concrete foundation. The side-gable roof is covered with composition shingles and has close-raked, wood cornices and boxed eaves. An exterior stone chimney is centered on the northwest (side) elevation. Most window openings throughout the dwelling contain wood, six-over-one, double-hung windows with simple wood surrounds and decorative stone lintels, except where noted below. Decorative, two-panel wood shutters flank most windows. The basement window openings contain wood, three-light hopper windows. A pair of wood garage doors in the basement level of the dwelling's southeast (side) elevation provides vehicular access from the driveway. A small, one-story entry wing/mud room with a hipped roof is attached to the southwest (rear) elevation at the dwelling's south corner. Features of the Colonial Revival style include the symmetrical façade; accentuated front entry with gabled portico supported by slender Doric columns; double-hung windows with multi-pane glazing; and simple, rectangular massing with side-gable roof (McAlester 2013:408-432).

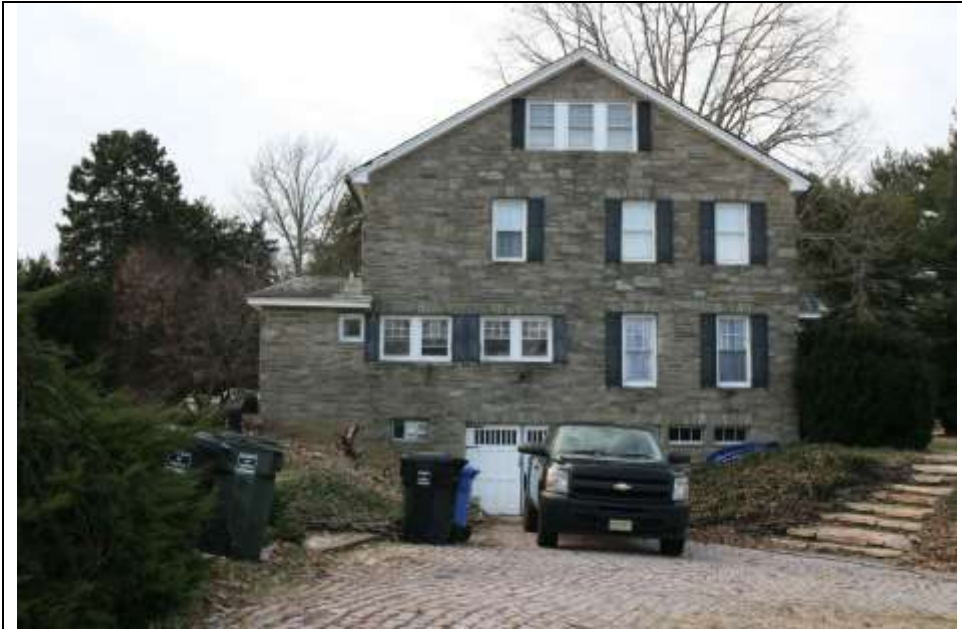
Photograph 2: Southeast (side) elevation of dwelling at 856 Main Street. Looking northwest (December 2018).

The southeast (side) elevation has an irregular fenestration pattern (Photographs 2 and 3). The driveway cuts through the slightly elevated, landscaped yard and extends all the way to the southeast elevation of the dwelling, where a pair of hinged, wood-paneled garage doors provides vehicular access to the basement level. The garage entrance is the southern bay in the basement level; the northern bay contains a series of three wood, three-light hopper windows. The first story of the dwelling's southeast elevation consists of two bays: the southern bay contains two paired windows that are slightly smaller than the typical windows; and the northern bay contains two single, typical windows. The second story consists of two window bays, with the southern bay containing one typical window and the northern bay containing two typical windows. The attic level contains a series of three windows that are slightly smaller than typical. The southeast elevation of the small, one-story, rear wing consists of one bay containing a single, wood, one-light, fixed window.

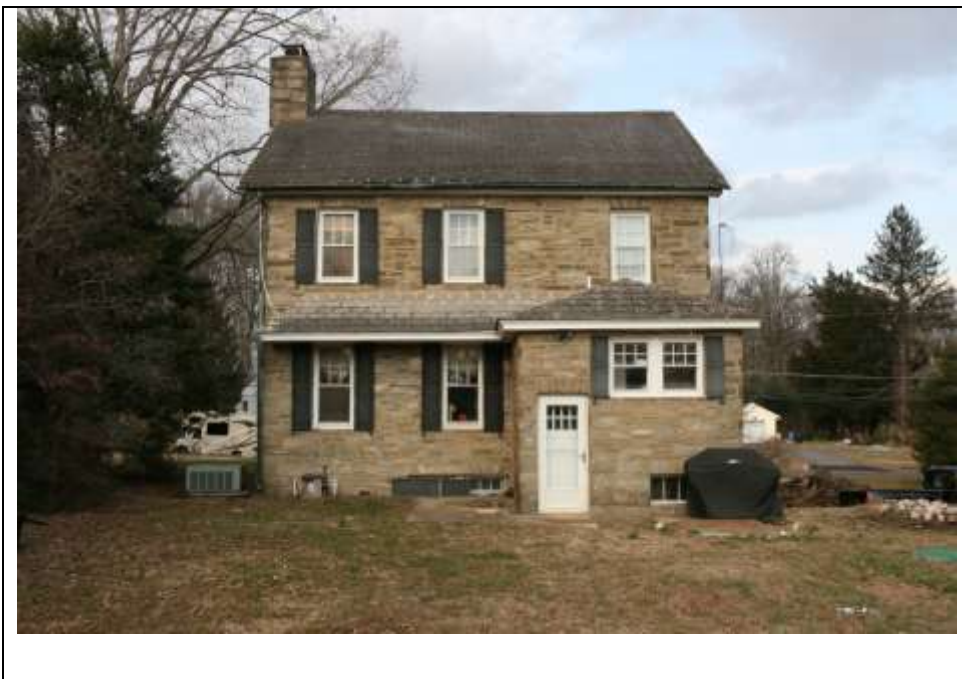
Photograph 3: Southwest (rear) elevation of dwelling at 856 Main Street. Looking northeast (December 2018).

The symmetrical southwest (rear) elevation consists of three bays in both stories, though the eastern bay in the first story of the main block is obstructed by the one-story rear wing (Photograph 3). The two visible window bays in the first story each contain a single typical window. A pent roof extends across the top of the first story. The southwest elevation of the rear wing consists of a ground-level entrance containing a wood, eight-light-over-two-panel door and a paired window (slightly smaller than typical) set high in the elevation. The second story of the main block consists of three window bays, each containing a single typical window.

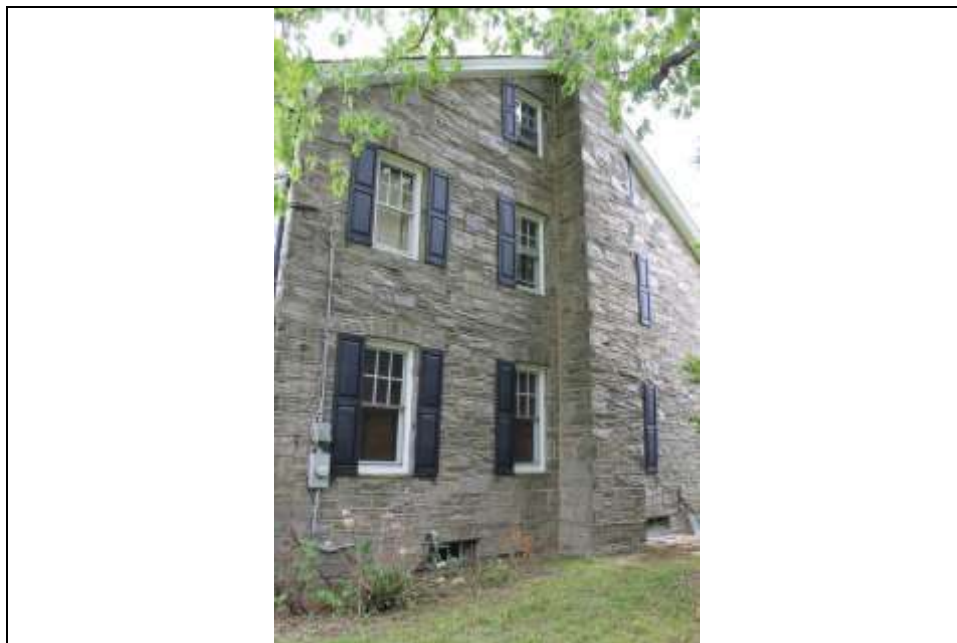
Photograph 4: Northwest (side) elevation of dwelling at 856 Main Street. Looking south (May 2014).

The northwest (side) elevation consists of three vertically aligned window bays, each containing a single typical window, in the first and second stories (Photograph 4). The attic level contains two windows that are slightly smaller than typical. A stone exterior chimney is entered in the elevation.

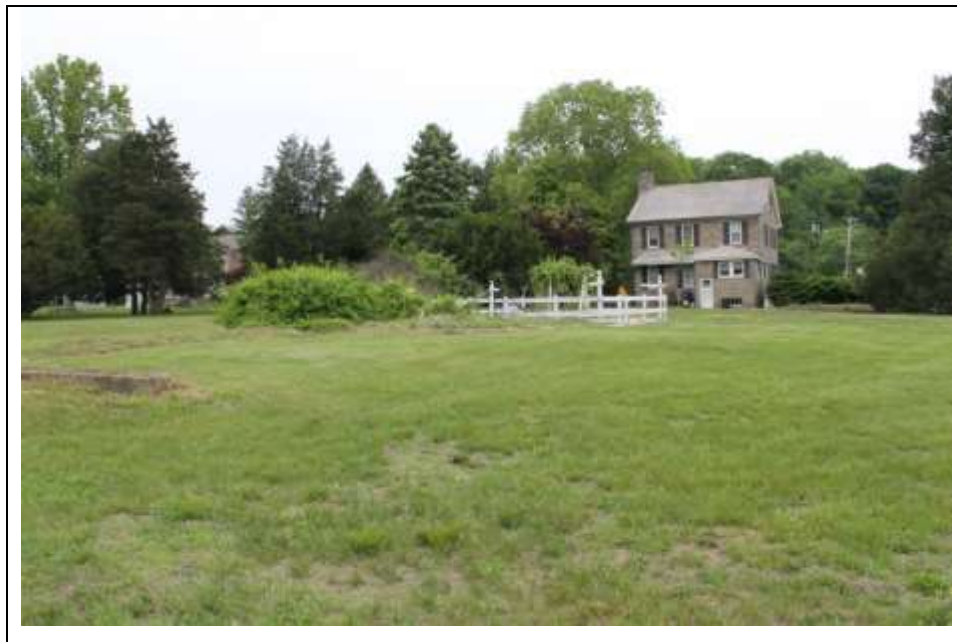
Photograph 5: Overview of the property at 856 Main Street from the rear yard, showing the fenced garden (mid-ground) and partial foundation of a former outbuilding (foreground). Looking northeast toward the dwelling (May 2014).

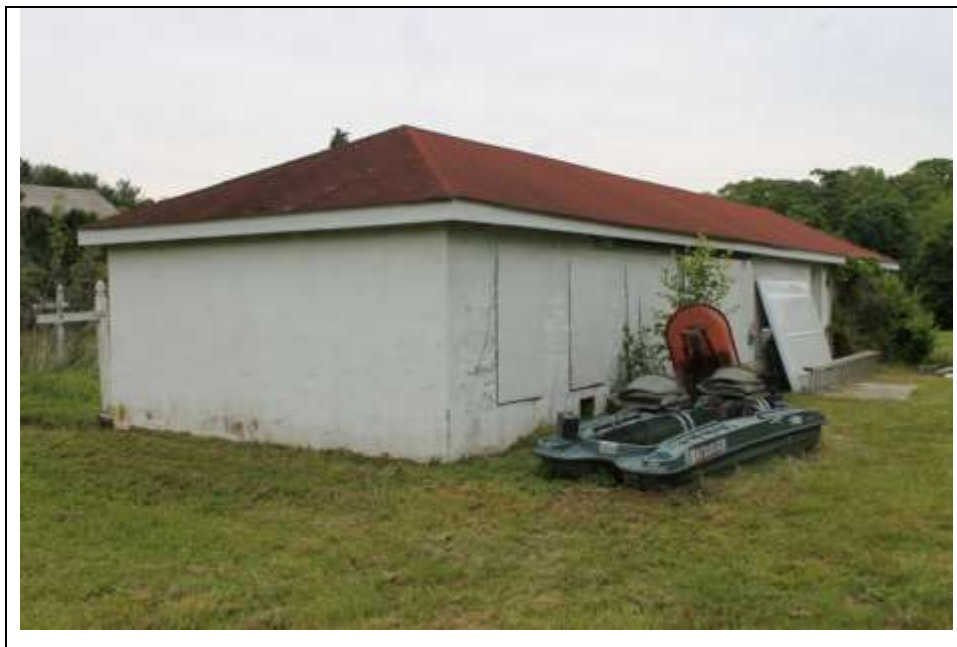
Photograph 6: Northwest (side) and southwest (front) elevations of the animal shelter at 856 Main Street. Looking east (May 2014).

Exterior Description: The *circa*-1920 animal shelter (possibly a former dog kennel) is located in the rear yard, situated approximately 155 feet southwest of the dwelling (Photographs 6 and 7). The one-story, cinderblock structure is partially clad with stucco. The hipped roof is covered in asphalt shingles. The building faces southwest, away from the dwelling. The southwest elevation (façade) consists of seven bays (from west to east: window, window, window, door, window, window, door). The window openings in Bays 1 to 3, 5, and 6 (counted from the west end) are covered with plywood. Bay 4 contains a sliding, wood, vertical plank barn door. Bay 7 contains a wood, three-light over two-panel pedestrian door. The northwest and southeast (side) elevations do not contain any openings. The northeast (rear) elevation contains eight evenly spaced, rectangular openings along the bottom of the elevation. A chain link fence enclosure abuts the building's southeast (side) elevation. A wire fence enclosure abuts the northeast (rear) elevation, with wood posts (presumably used for securing animals on tethers) at evenly spaced intervals along the fence.
