- 77 and 78 East Center Street, Woodbury City, Gloucester County
- 856 Main Street, Mantua Township, Gloucester County
- Tyler's Mill Road Bridge over Chestnut Branch, Mantua Township, Gloucester County
- 628-634 Kaighns Avenue (Victory Garage), Camden City, Camden County

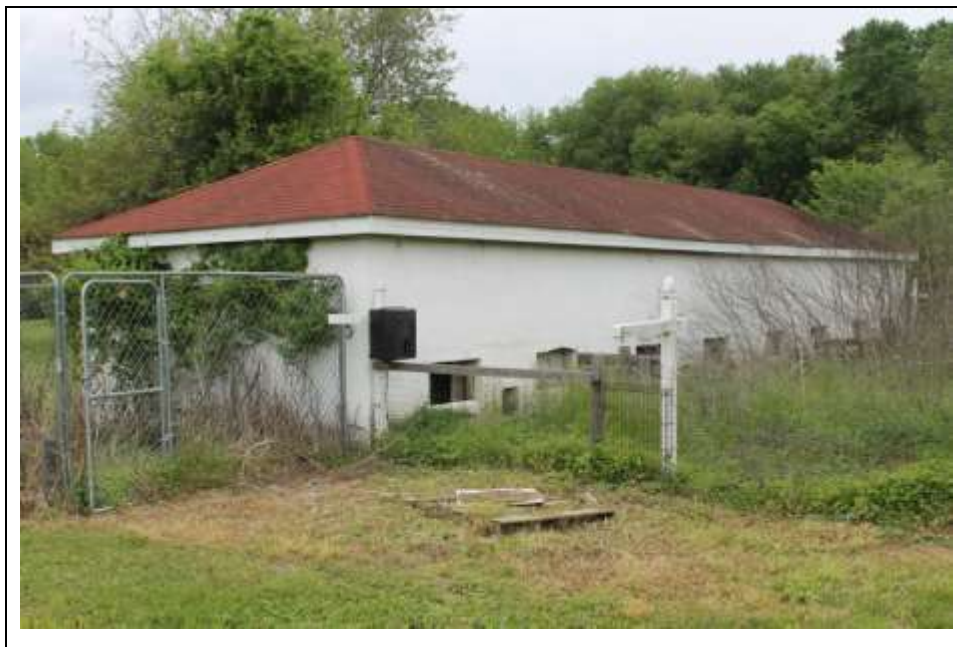
Photograph 7: Southeast (side) and northeast (rear) elevations of animal shelter at 856 Main Street. Note the side and rear fenced enclosures. Looking west (May 2014).

Exterior Description: The *circa*-1920 animal shelter (possibly a former dog kennel) is located in the rear yard, situated approximately 155 feet southwest of the dwelling (Photographs 6 and 7). The one-story, cinderblock structure is partially clad with stucco. The hipped roof is covered in asphalt shingles. The building faces southwest, away from the dwelling. The southwest elevation (façade) consists of seven bays (from west to east: window, window, window, door, window, window, door). The window openings in Bays 1 to 3, 5, and 6 (counted from the west end) are covered with plywood. Bay 4 contains a sliding, wood, vertical plank barn door. Bay 7 contains a wood, three-light over two-panel pedestrian door. The northwest and southeast (side) elevations do not contain any openings. The northeast (rear) elevation contains eight evenly spaced, rectangular openings along the bottom of the elevation. A chain link fence enclosure abuts the building's southeast (side) elevation. A wire fence enclosure abuts the northeast (rear) elevation, with wood posts (presumably used for securing animals on tethers) at evenly spaced intervals along the fence.

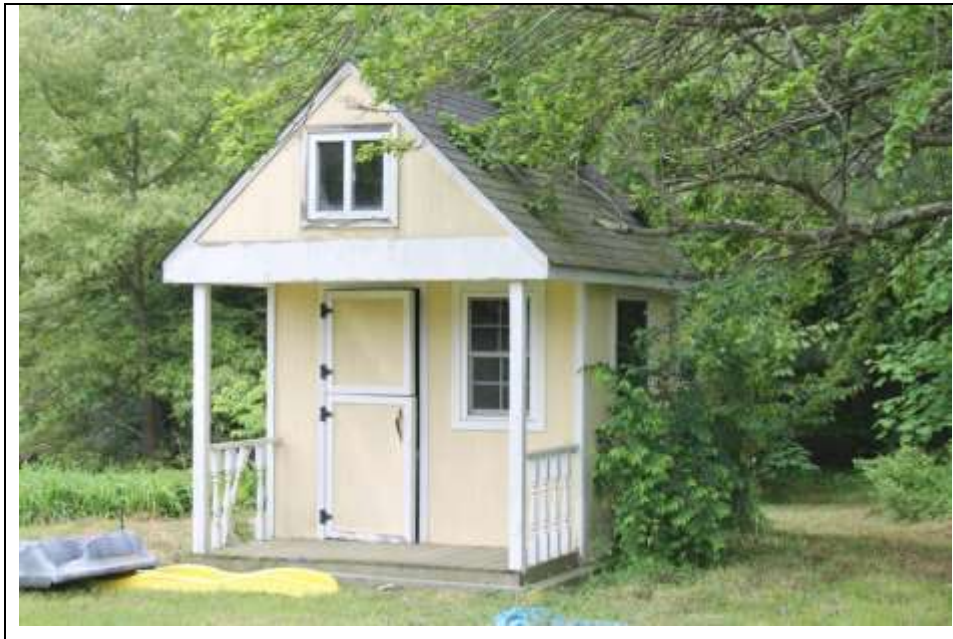
Photograph 8: North and west elevations of modern playhouse at 856 Main Street. Looking southeast (May 2014).
