Appendix 7-A: Historic Reconnaissance Reports

Re: Historic Architectural Reconnaissance Survey Report
Glassboro-Camden Line Light Rail Project, Camden and Gloucester Counties, New Jersey

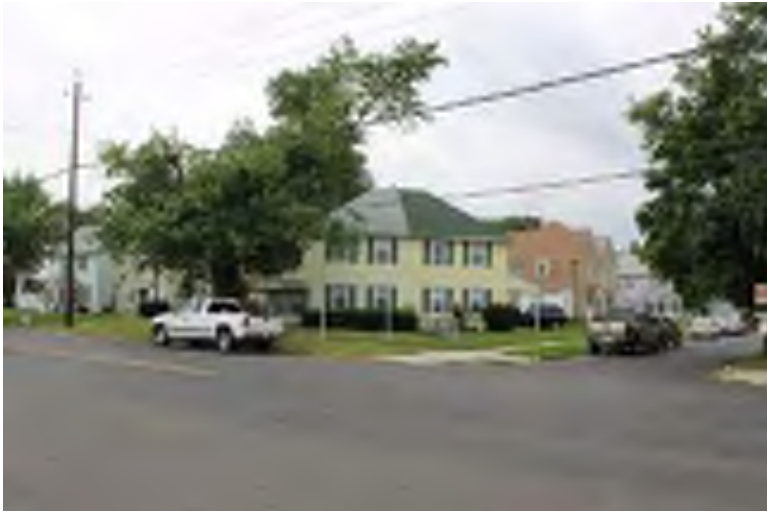
Photograph 1: Noreg Village Historic District (NR eligible), Brooklawn Borough. View looking west at New Broadway and New Jersey Road.

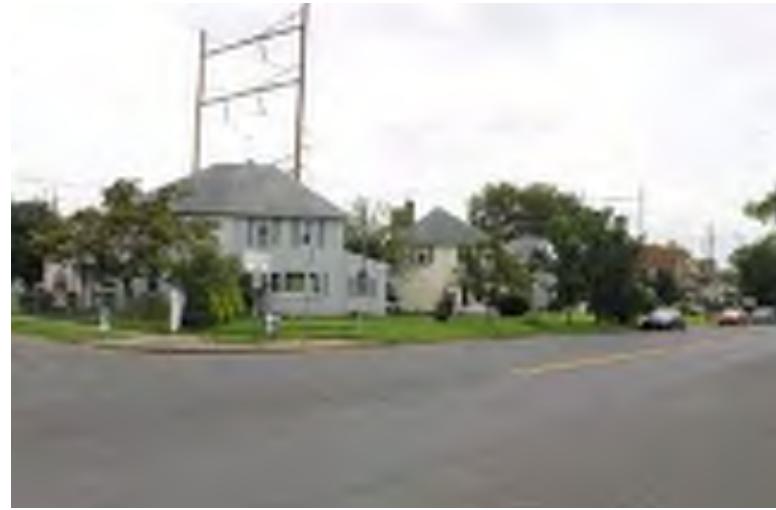
Photograph 2: Noreg Village Historic District (NR eligible), Brooklawn Borough. View looking southwest along New Broadway.

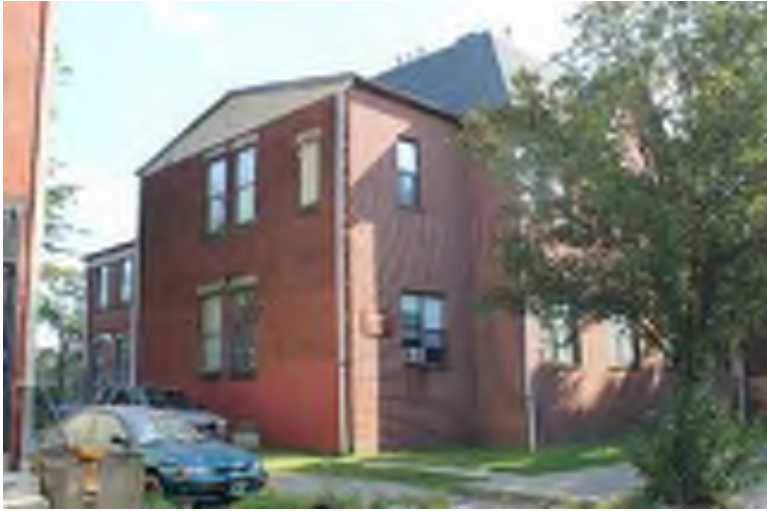
Photograph 5: Jesse Starr School (NR eligible), 823 Pine Street, Camden City. View of façade and west (side) elevation. The building has lost integrity as a result of extensive alterations since the previous evaluation and appears to be no longer eligible for listing in the NR.

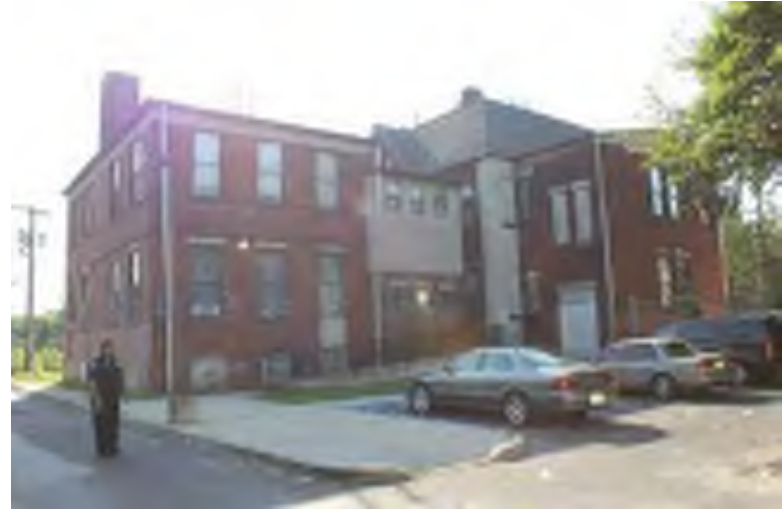
Photograph 6: Jesse Starr School (NR eligible), 823 Pine Street, Camden City. View of north (rear) and west (side) elevations, showing alterations.

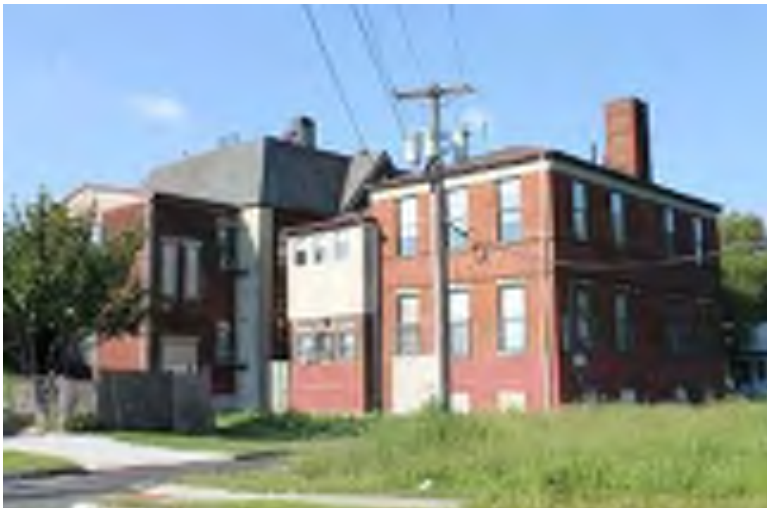
Photograph 7: Jesse Starr School (NR eligible), 823 Pine Street, Camden City. View of north (rear) and east (side) elevations, showing alterations.

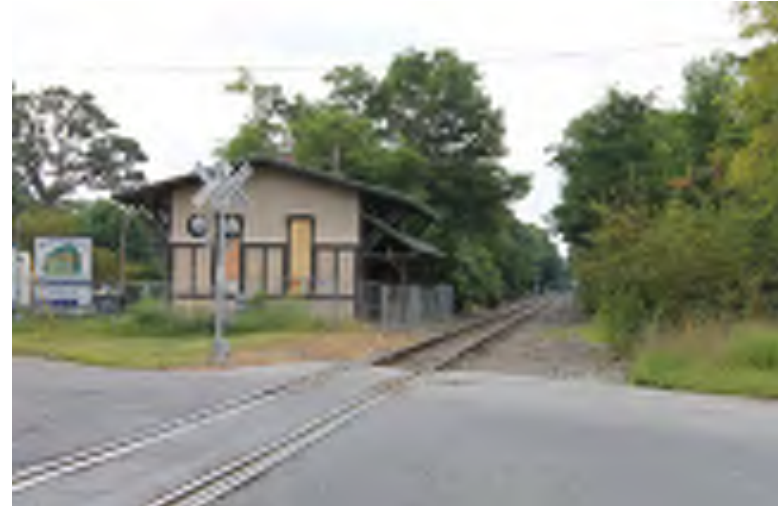
Photograph 10: Glassboro Train Station and Millville and Glassboro Railroad Historic District (both NR eligible), Glassboro Borough. View looking southeast from Oakwood Avenue.

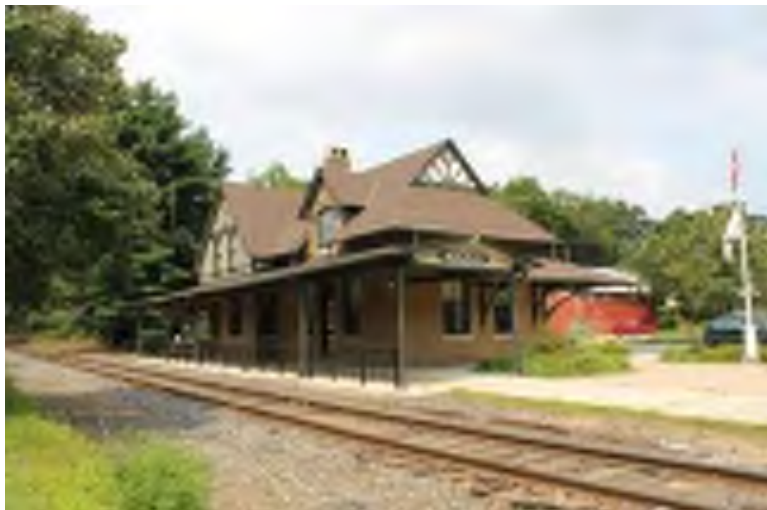
Photograph 15: Wenonah Train Station (NR eligible), Wenonah Borough.

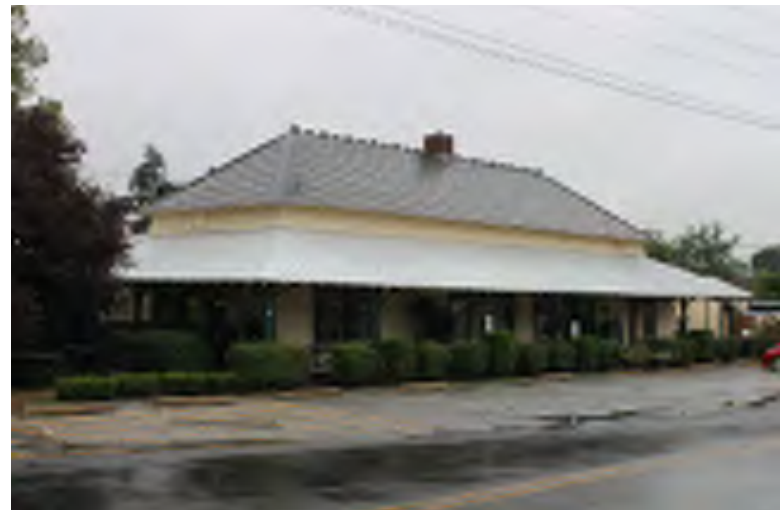
Photograph 16: Woodbury Train Station, a contributing resource to the Green Era Historic District (NR eligible; SR Listed), Woodbury City.

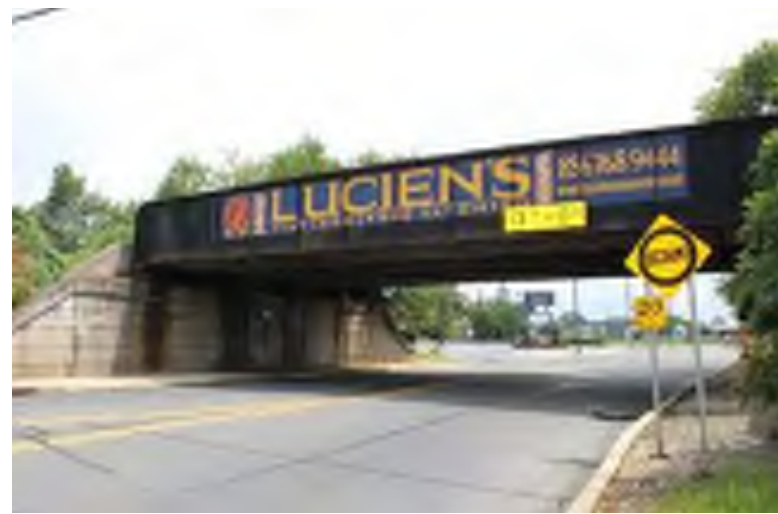
Photograph 22: West Jersey & Seashore Railroad/Pennsylvania Reading Seashore Lines, bridge over US 130, Brooklawn Borough.

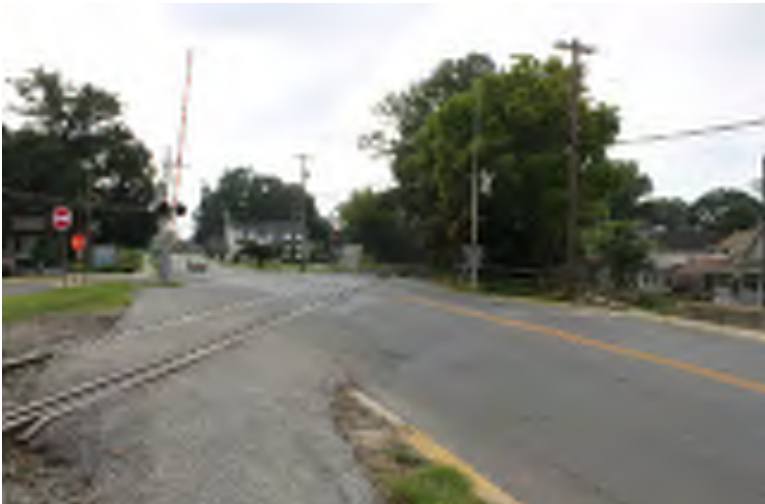
Photograph 23: West Jersey & Seashore Railroad/Pennsylvania Reading Seashore Lines, grade crossing at Broadway, Pitman Borough.

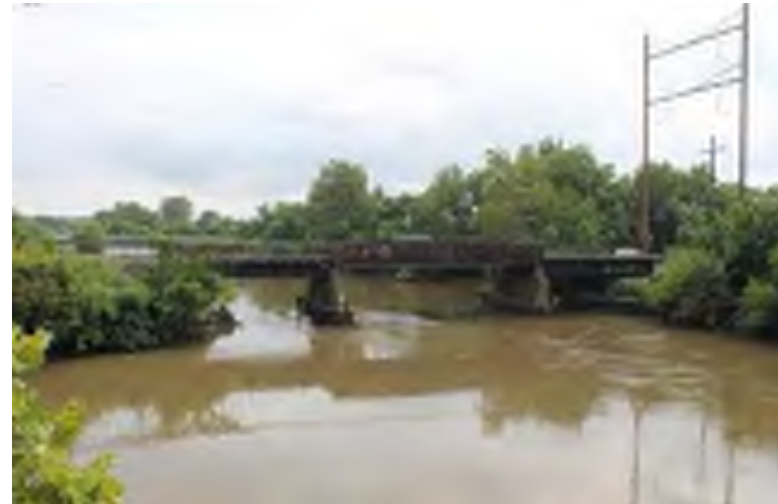
Photograph 24: West Jersey & Seashore Railroad/Pennsylvania Reading Seashore Lines, bridge over Big Timber Creek, Westville Borough.

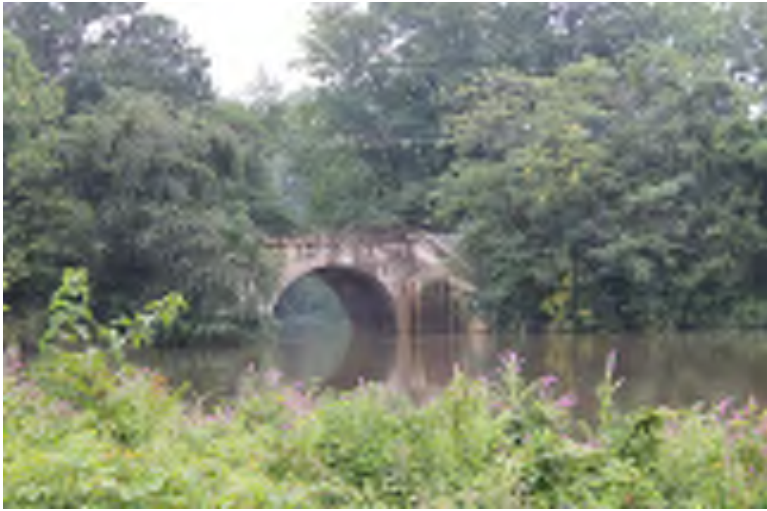
Photograph 25: West Jersey & Seashore Railroad/Pennsylvania Reading Seashore Lines, bridge over Woodbury Creek, Woodbury Township.

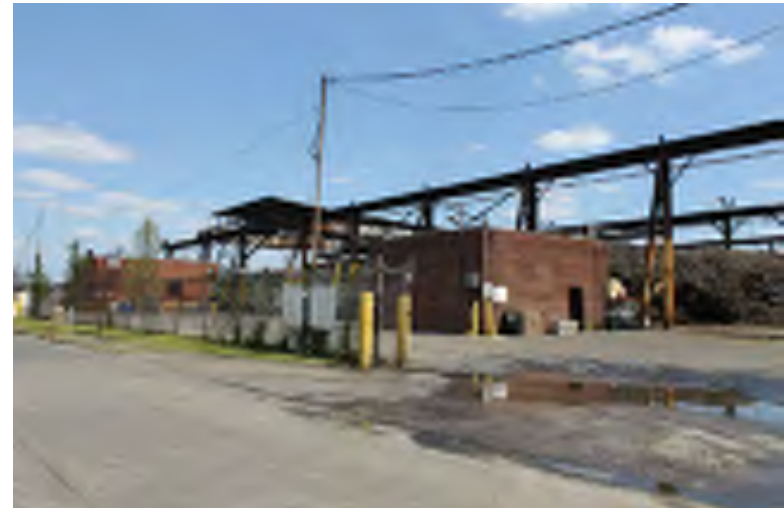
Photograph 30: 1500 S. 6th Street (Camden Iron and Metal), Camden City. View looking north. All that remains from the pre-1965 era are two small brick office buildings.

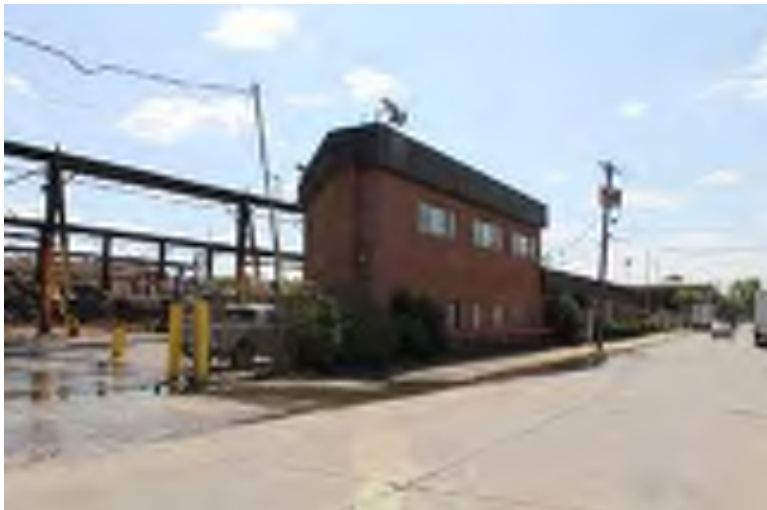
Photograph 31: 1500 S. 6th Street (Camden Iron and Metal), Camden City. View looking south. All that remains from the pre-1965 era are two small brick office buildings.

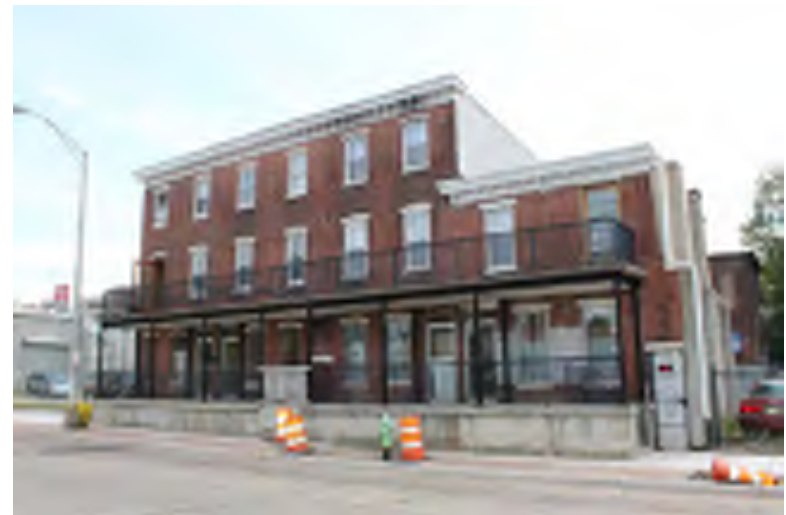
Photograph 47: 1 Cooper Plaza (Cooper University Hospital), Camden City. Extensive additions have compromised the resource's integrity.

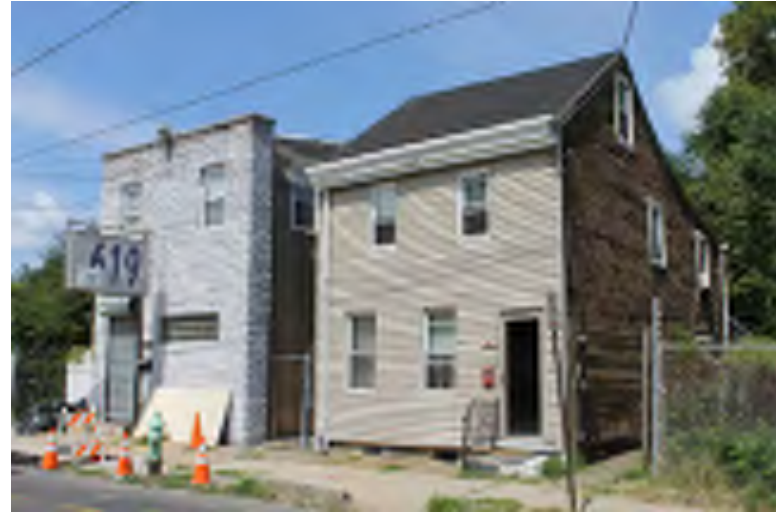
Photograph 49: 619 Ferry Street, Camden City. This resource is located outside of the revised South Camden Historic District boundary proposed in 2008. Clarification of the approved boundary is required.

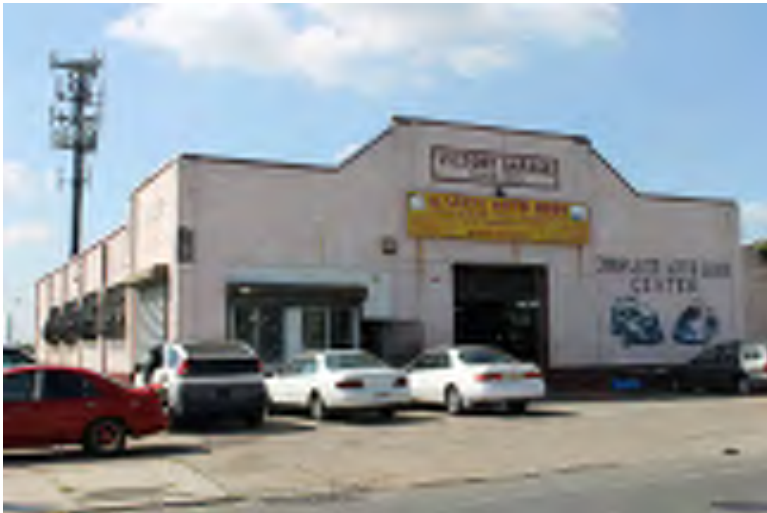
Photograph 50: 621 Ferry Street, Camden City. This resource is located outside of the revised South Camden Historic District boundary proposed in 2008. Clarification of the approved boundary is required.

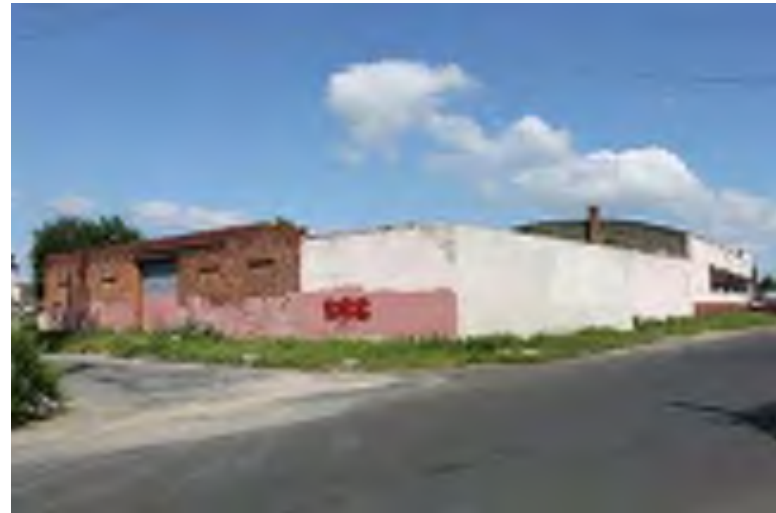
Photograph 51: 628-634 Kaighns Avenue (Victory Garage), Camden City. View of façade.

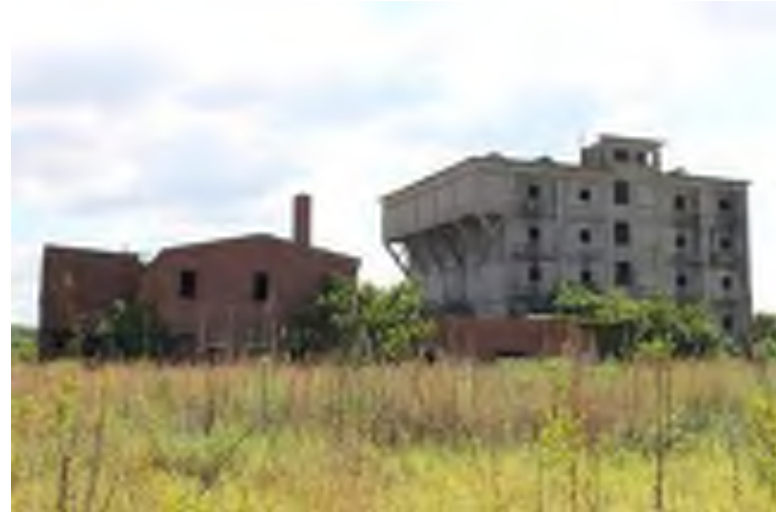
Photograph 69: Railroad Avenue/S. 7th Street at Kaighns Avenue (Farr & Bailey Manufacturing Company/Congoleum Nairn Company) Linoleum Plant, Camden City. View looking south from Kaighns Avenue.

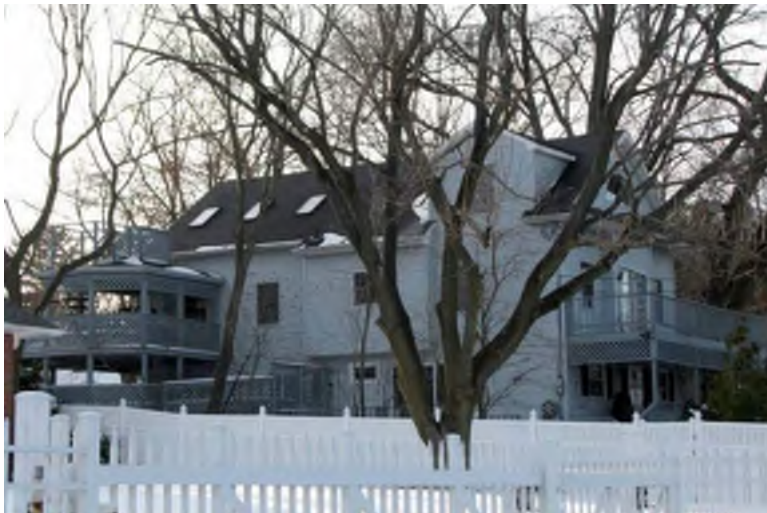
Photograph 23: 306 Mullica Hill Road, Glassboro Borough. Aerial photographs of the early- to mid-1960s show a building at this location; however, it is unclear if the extant dwelling has had extensive additions or was entirely rebuilt.

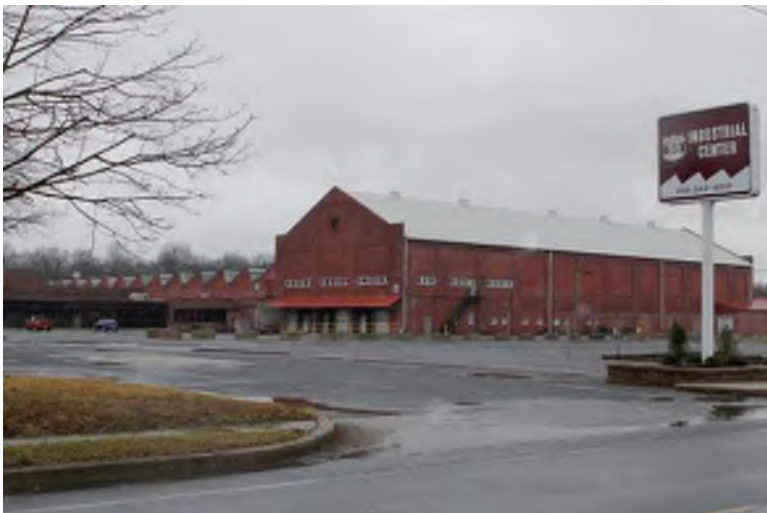
Photograph 31: 70 Sewell Street (Owens Illinois Glass Company/ former Owens Bottle Company) Plant No. 8, Glassboro Borough. View looking southwest from Sewell Street.

- ADM Survey No. 233 (Owens Illinois Glass Company Plant No. 8, 70 Sewell Street, Glassboro Borough) is located at the site of the proposed VMF Site 4A. This facility opened in 1918 and operated as a glass bottle plant until 1929. Preparation of an intensive-level survey form for this resource is recommended to determine its NR eligibility.
- ADM Survey No. 269 (7 N. Evergreen Avenue, Woodbury City). This *circa*-1910, Colonial Revival style dwelling is located within the boundary of the SR-listed/NR-eligible Green Era Historic District (Woodbury Multiple Resource Area); however, the property is not included in the NR inventory for the district. Preparation of an intensive-level survey form is recommended for this resource to determine its contributing status to the district.

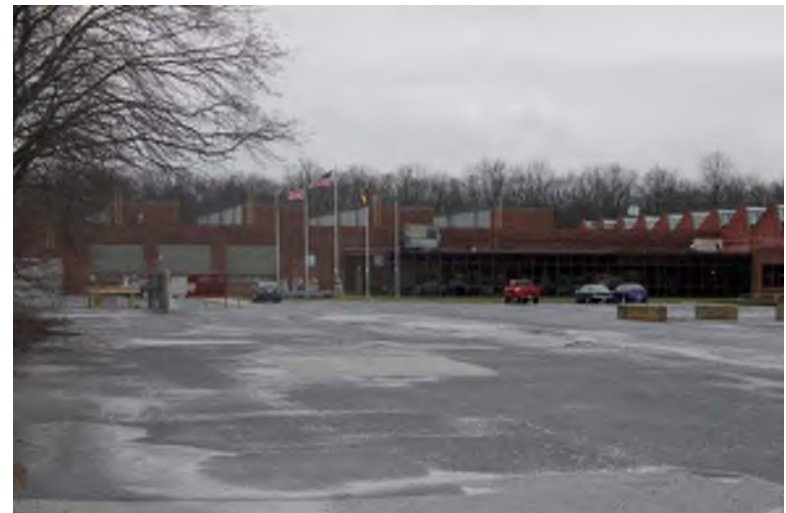
Photograph 32: 70 Sewell Street (Owens Illinois Glass Company/ former Owens Bottle Company) Plant No. 8, Glassboro Borough. View looking south from Sewell Street.

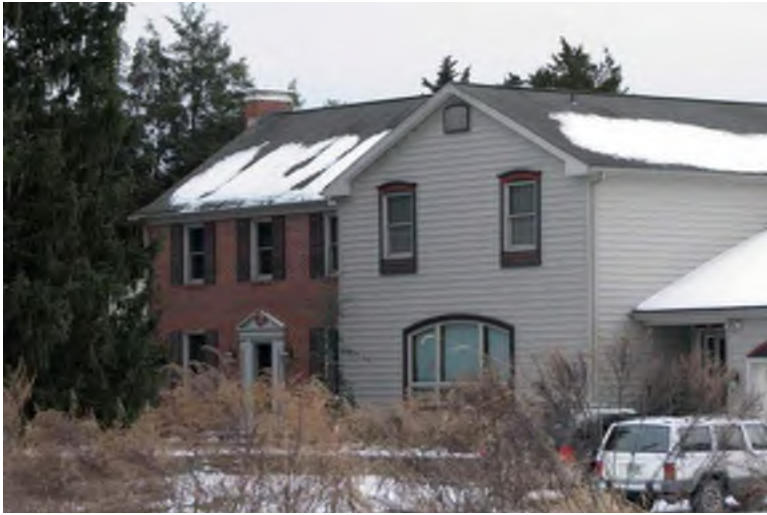
Photograph 52: 844 Main Street, Mantua Township. Overview showing extensive *circa*-2000 additions.

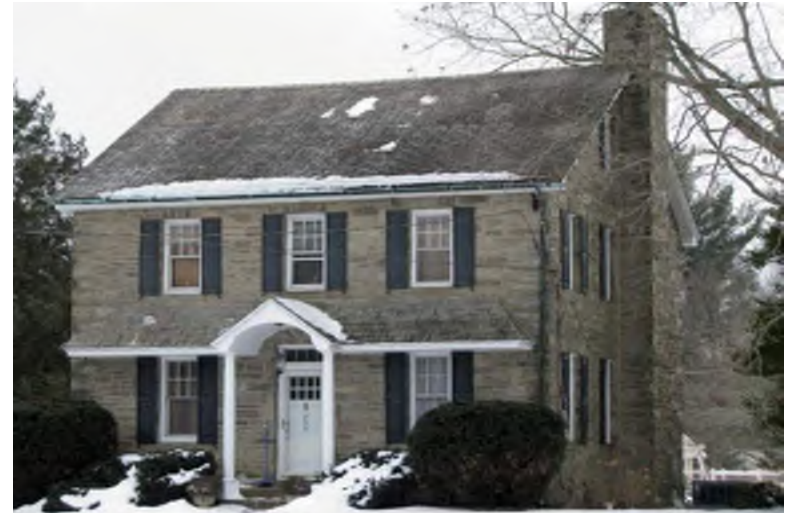
Photograph 53: 844 Main Street, Mantua Township. Detail of original dwelling facade (left) and *circa*-2000 addition.

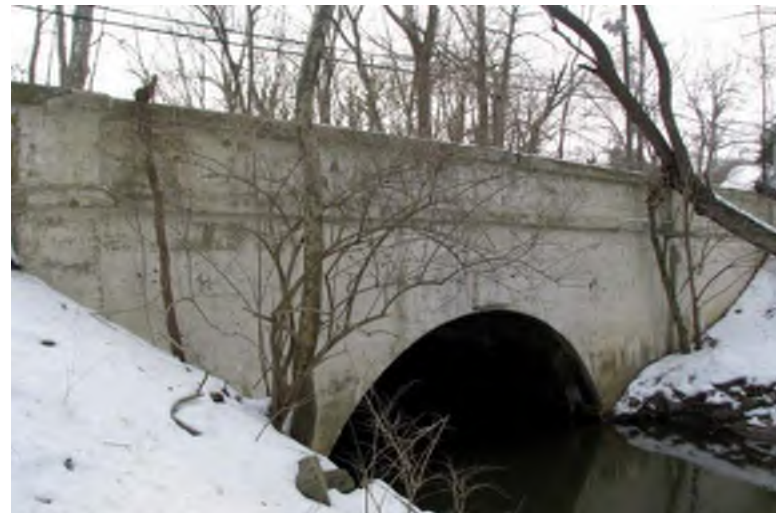
Photograph 67: Tylers Mill Road Bridge over Chestnut Branch (Structure No. 0805102), Mantua Township. View showing the south elevation. The 1926 bridge was previously surveyed and determined not eligible in 1995.

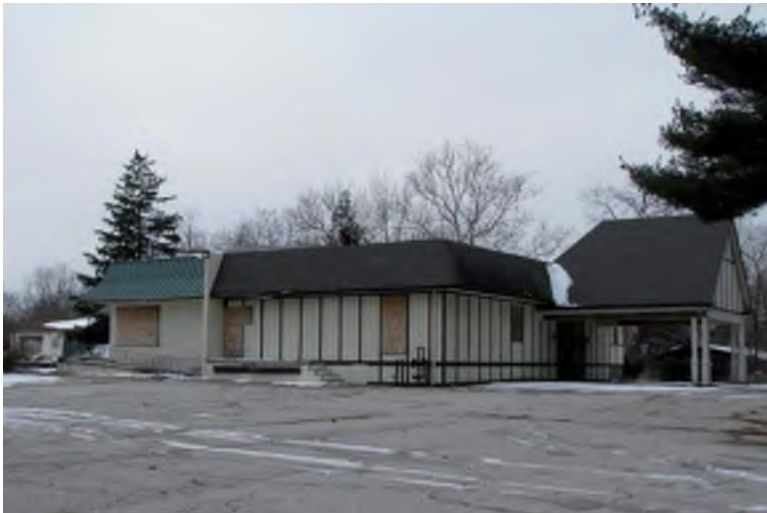
Photograph 71: 467 Cooper Street (former Woodbury Country Club), Woodbury City. The Woodbury Country Club was founded in 1897, using an 18th-century farmhouse as the clubhouse. The clubhouse has been completely engulfed with additions and there are no other extant buildings from the late 19th to mid-20th centuries.

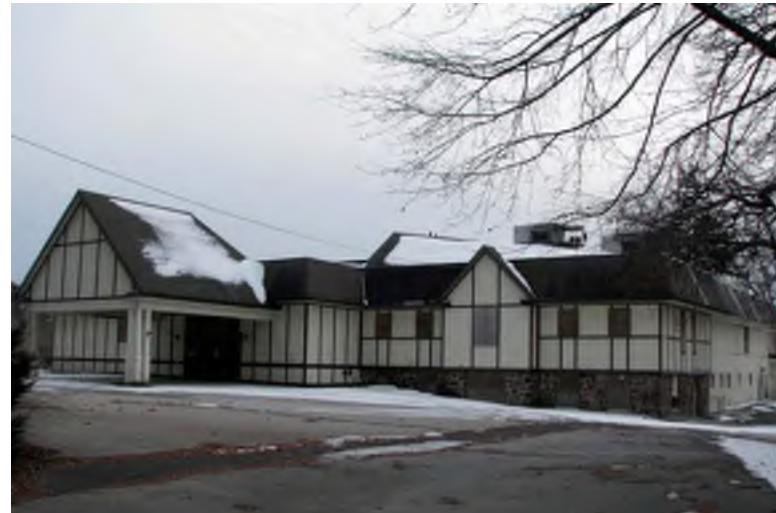
Photograph 72: 467 Cooper Street (former Woodbury Country Club), Woodbury City. The Woodbury Country Club was founded in 1897, using an 18th-century farmhouse as the clubhouse. The clubhouse has been completely engulfed with additions and there are no other extant buildings from the late 19th to mid-20th centuries.

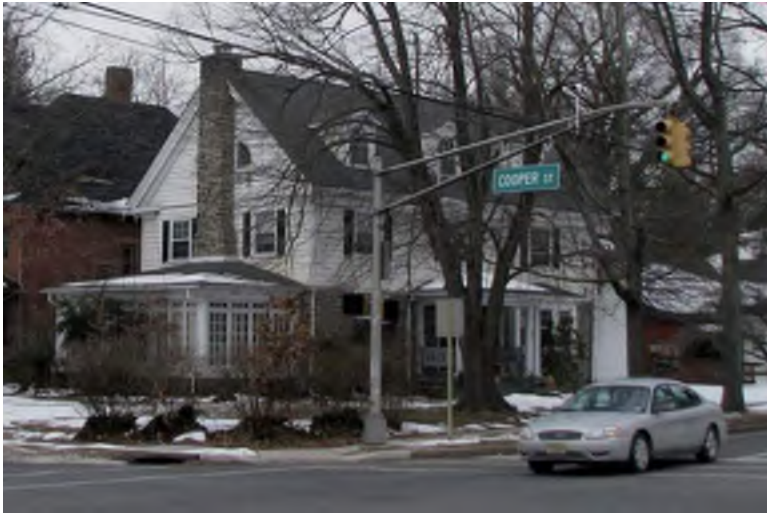
Photograph 73: 7 N. Evergreen Avenue, Woodbury City. This property is located within the boundary of the NR-eligible/SR-listed Green Era Historic District; however, it is not included in the district inventory. Additional investigation is recommended to determine its contributing status to the district.

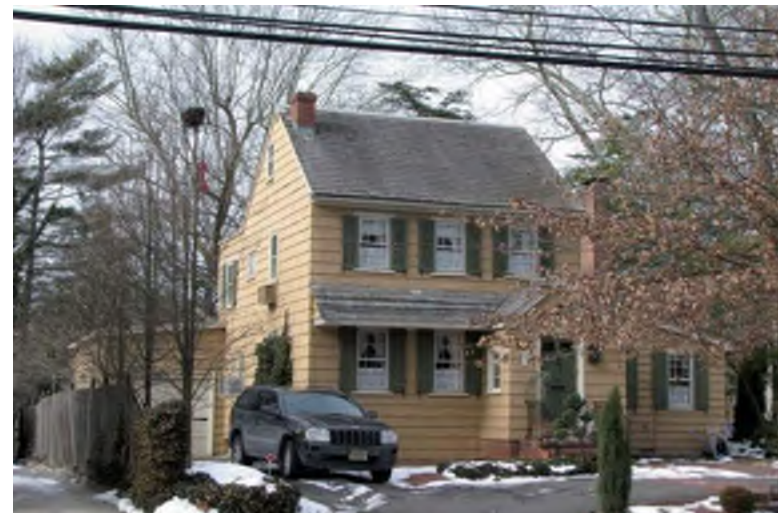
Photograph 75: S. Evergreen Avenue and S. Woodland Avenue Rowhouses, Woodbury City. Representative view of 67 S. Evergreen Avenue.

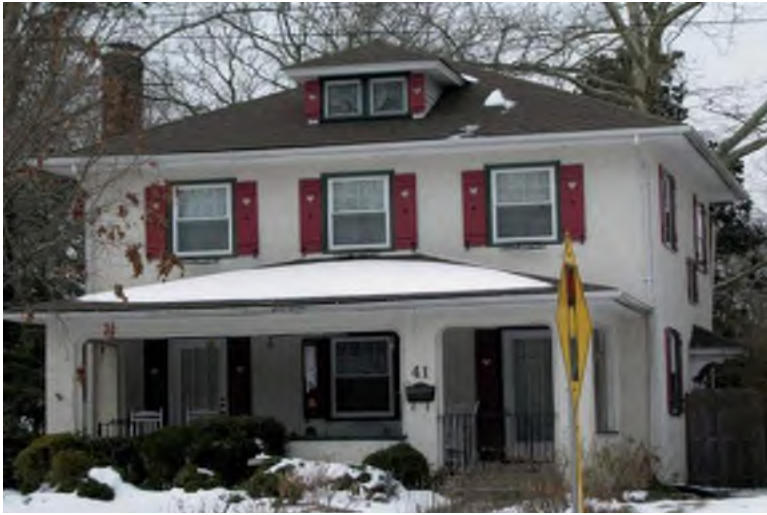
Photograph 76: S. Evergreen Avenue and Woodside Place Grouping, Woodbury City. Representative view of 49 S. Evergreen Avenue.

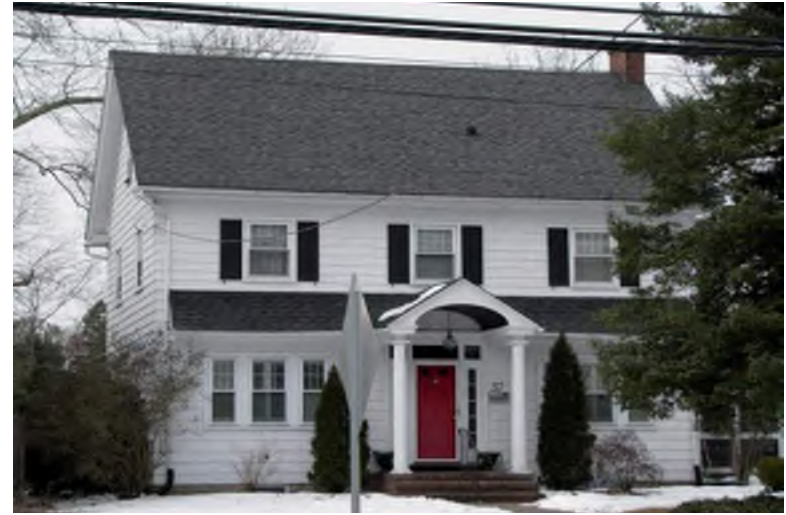
Photograph 77: S. Evergreen Avenue and Woodside Place Grouping, Woodbury City. Representative view of 41 S. Evergreen Avenue.

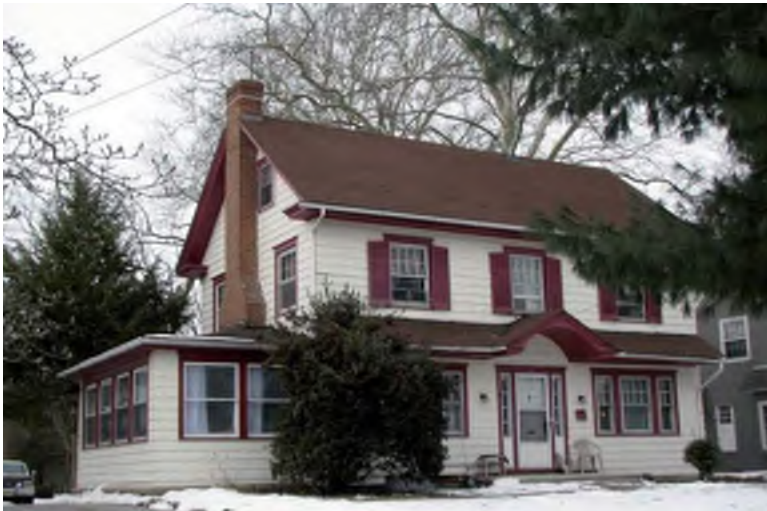
Photograph 78: S. Evergreen Avenue and Woodside Place Grouping, Woodbury City. Representative view of 37 S. Evergreen Avenue.

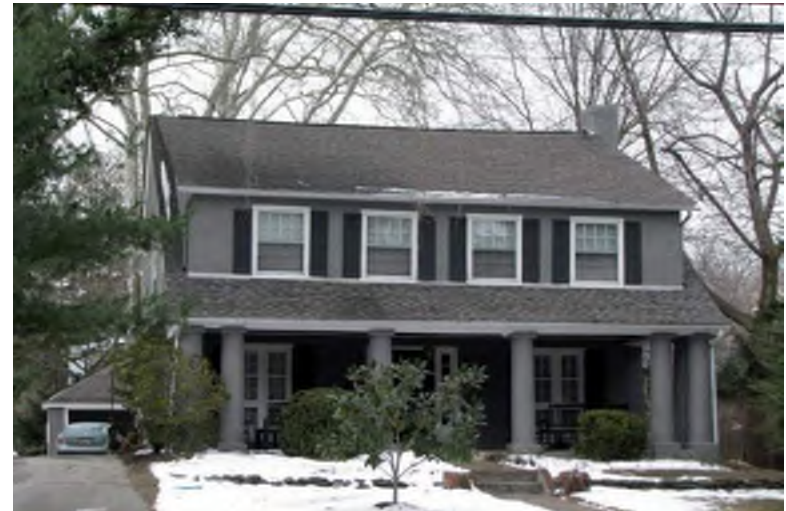
Photograph 79: S. Evergreen Avenue and Woodside Place Grouping, Woodbury City. Representative view of 31 S. Evergreen Avenue.

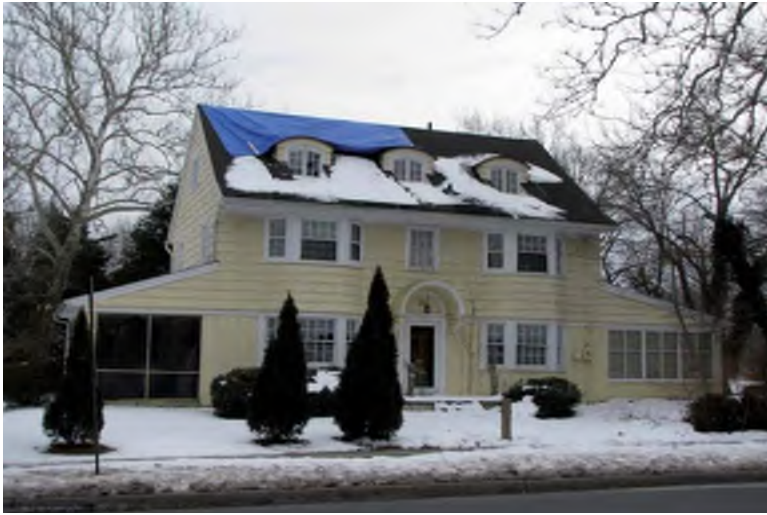
Photograph 80: S. Evergreen Avenue and Woodside Place Grouping, Woodbury City. Representative view of 25 S. Evergreen Avenue.

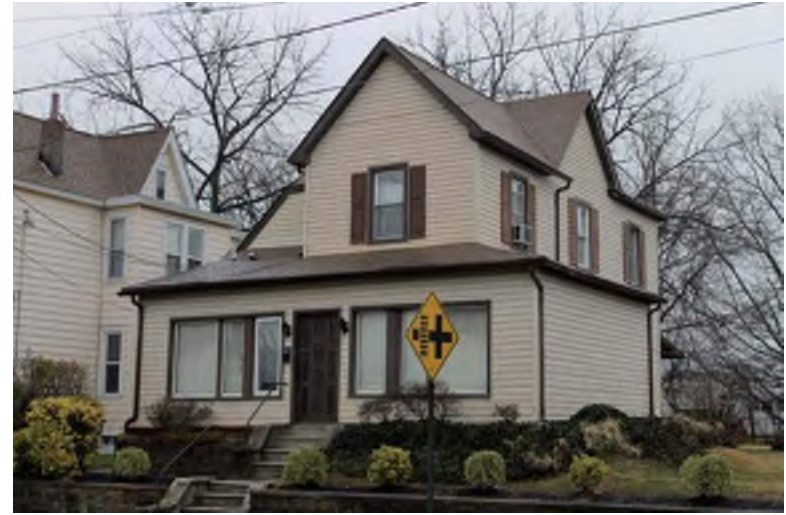
Photograph 81: S. Evergreen Avenue and Woodside Place Grouping, Woodbury City. Representative view of 30 S. Evergreen Avenue.
